8802-3/802.3 REVISION REQUEST 1167	
ATE:	30th March, 2005
AIE:	Yair Darshan
AME: OMPANY/AFFILIATION:	
-MAIL:	yaird@powerdsine.com
EQUESTED REVISION:	
STANDARD:	IEEE Std. 802.3af-2003
CLAUSE NUMBER:	
CLAUSE TITLE:	PSE State diagram
ROPOSED REVISION TE	XT:
dd now wariahla ant	ion tmort30 to 33 2 3 4. It will be an entional
	ion_vport30 to 33.2.3.4. It will be an optional te diagram (figure 33-6) per the attached drawing.
arrabic. Change sta	ce aragram (rigure 33 of per the accached drawing.
ption_vport30	
	icating PSE port voltage.
lues:	reacting IDE porc vorcage.
lse: Vport is abov	2077
rue: Vport is below	
im minimum may be	
In militmum may be	SHOLCEH CO IMS.
	OM .
ATIONALE FOR REVISI	OIN:
ne state diagram all	ows a scenario that violates the minimum requirement
	in table 33-5 item 21 when PSE-PD motor-boating or
	peak power during short circuit condition.
9	
he proposed revision	n allows the option of preventing such scenarios.

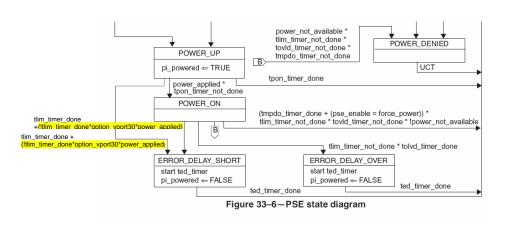
roblem description:	
uring short circuit	condition, PD input voltage is dropping below
off=30V (table 33-1	2 item 8) the PD enters to its OFF mode and the PD
	ischarged partially or completely pending the short
ircuit condition du	ration.
the grownest !	own love so the DCE realtons in mains high south
	ery low so the PSE voltage is going high again and
	Von value (30V to 42) it charge the PD capacitor
ain by drawing Iin	rusn.
DOE 1701+000 17:11	drop again holow Woff of the DD (2011) and the
	drop again below Voff of the PD (30V) and the
rocess will be repe	ated until TLIM is done.
he results of this	conario are:
TE LEBUILS OF CHIES	scenario are.
The time between	the first startup to the 2nd is much below Ted=750ms

which violates spec requirements of keeping cool off time between

consecutive startups.

It should be noted that while PSE is in POWER\_APPLIED status, the PD is in OFF or Startup state that's why Ted can not be controlled (From system point of view, there is no synchronization between PSE state and PD state).

Effectively the PSE may faces multiple inrush time duration which is 50ms minimum. According to the state diagram, Tlim starts counting once I>Iinrush and nothing can stop the counter until 50ms to 75ms time is reached. This scenario may generate excessive heat which should have been prevented by Ted minimum value 750mS as explained above.

- 2. Until TLIM timer done, the PSE and PD will pass few consecutive cycles of startups which as function of the short circuit time duration and the status of the PD during short will cause PSE-PD motor boating at high peak power, may generating noise and in some cases will cause PSE-PD stability issues due to the fact that the PSE during short circuit is a current source with high impedance that drives negative input impedance of the PD DC/DC if PD is ON and PSE still in current limit.
- 3. In addition, to prevent shutting down the port for short transients, it is recommended to set 1ms minimum value for Tlim.

In order to handle this scenario, we need to allow to shut the PSE port if Vport is below a value that cause PD to be at OFF.

Such Vport value exist in the spec, the 30V border line in the PD spec which is Voff per table 33-12 item 8 .

Using this optional variable in the state diagram will fix the problem by changing the inputs to ERROR\_DELAY\_SHORT state from: tlim\_timer\_done to: Tlim\_timer\_done + !tlim\_timer\_done\*option\_vport30\*power\_applied
