receive\_DME\_active in
DELIMITER WAIT state of
Figure 98-9 Receive state diagram

Niall Fitzgerald

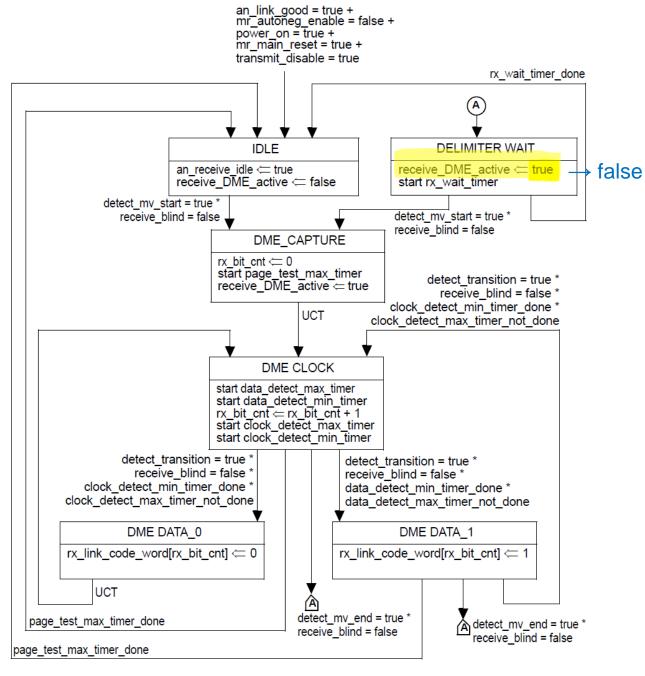
- DELIMITER WAIT state is entered after successful completion of reception of DME page from the link partner (condition detect\_mv\_end = true).
- No DME page reception is ongoing in DELIMITER WAIT
  - receive\_DME\_active should be assigned to false
  - But Figure 98-9 currently shows it as assigned to true
- Description of variable from subclause 98.5.1:

receive\_DME\_active

Status indicating whether or not a DME page reception is in progress.

Values:

true: DME page reception in progress

false: DME page reception completed

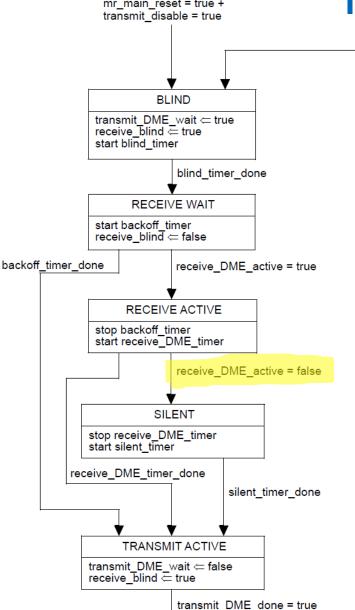
- Figure 98-10 Half-duplex state diagram
- The intended flow here is straightforward, i.e. to transition through each state in turn, and repeat.
- Purpose of receive\_DME\_active is to keep Half-duplex state diagram synchronized with receive activity.
- When DME page reception is ongoing, this state machine will be in the RECEIVE ACTIVE state
  - Waiting for completion of DME page reception, i.e. the condition receive\_DME\_active = false.
- Once the DME page reception has completed, the Receive state machine will enter DELIMITER WAIT, but currently it does not assert receive\_DME\_active = false there.
- Exit from RECEIVE ACTIVE then relies on receive\_DME\_timer\_done, and the transition skips SILENT
  - This timer is defined in subclause 98.5.2
  - Timer for the maximum amount of time to receive a complete page before timeout.

- Half-duplex state diagram intended to operate as follows:
  - Once either PHY successfully receives a DME page, then both PHYs will fall into a pattern of alternating DME page transmission and reception. One PHY will transmit and the other PHY receives, and then the other PHY transmits and the one PHY receives.

- Auto-Negotiation (i.e. Arbitration state diagram) will then proceed to completion quickly.
- Issue with receive\_DME\_active in DELIMITER WAIT means that Half-duplex state diagram and Receive state diagram do not remain in sync.

- Transition from RECEIVE WAIT to RECEIVE ACTIVE state occurs on receive\_DME\_active = true, but the Receive state diagram is holding this at true, so this transition does not occur with start of DME page reception (detect\_mv\_start in Receive state diagram).

- Lack of synchronization can give rise to DME page collision:
  - A PHY might commence DME page transmission before ongoing reception of a DME page from the link partner has completed.

- The link partner might commence DME page transmission before ongoing local DME page transmission has completed.
- DME page collision will likely provoke rx\_wait\_timer\_done (in Receive state diagram):

- Causes transition back to IDLE, assertion of an\_receive\_idle = true, and Arbitration transition back to TRANSMIT DISABLE (restart of Auto-Negotiation).
