ACTA Virtual Public Meeting

ANSI/TIA-1096-A Non-Compliance Issues (Focus on RJ45)

Sentinel Connector Systems
Bob Brennan and Dave Jeskey

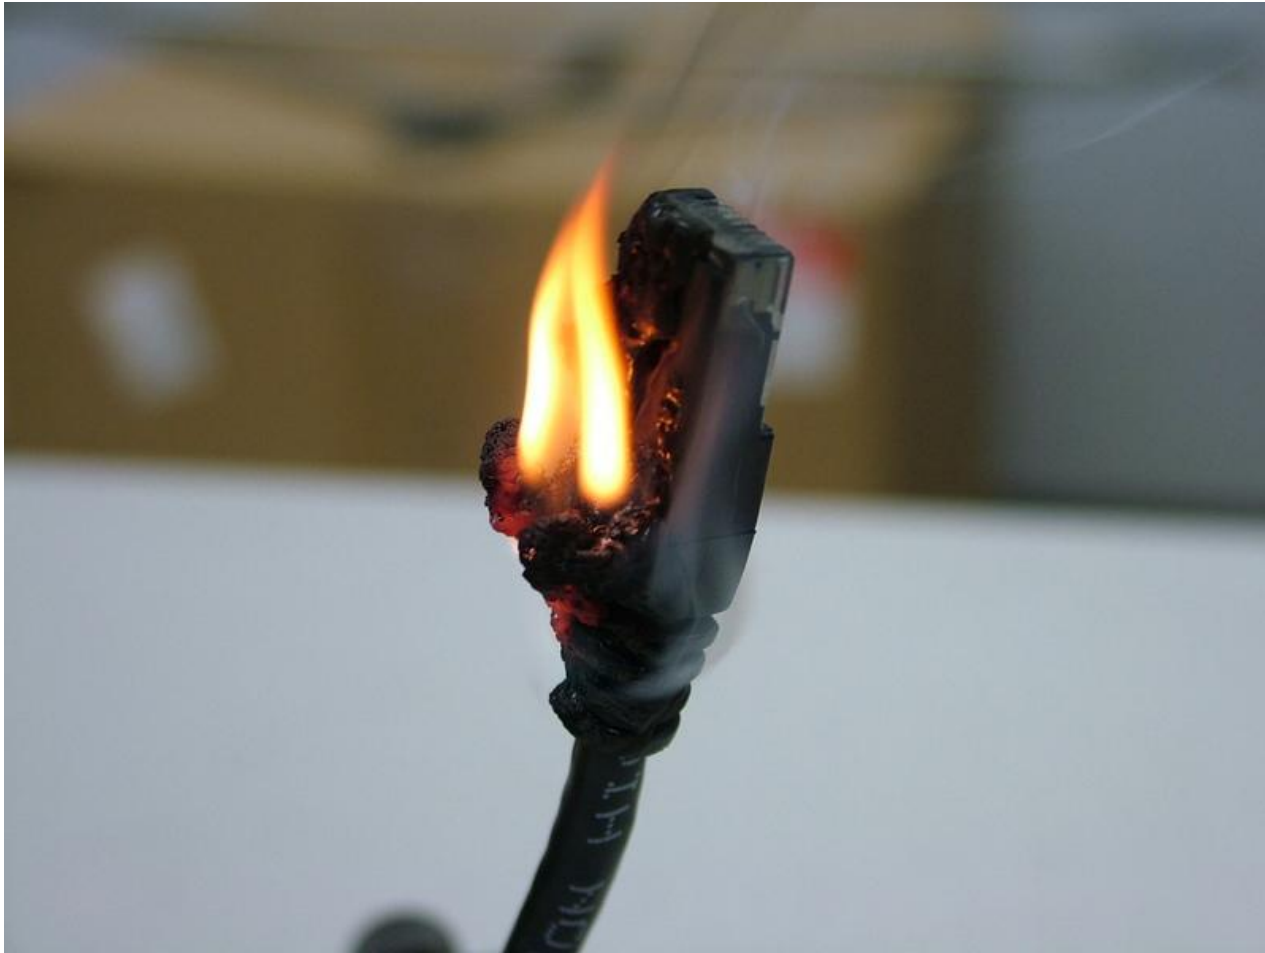
Sub-Standard Material – Violates UL

Use of 94V-2 Material (cheaper) instead of 94V-0

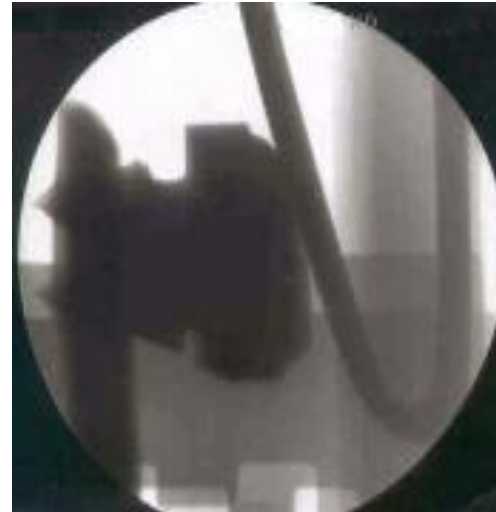
Several Factors are contributing to potential Signal Loss due to Improper Plug/Jack Mating

- Jack Width Being Too Wide
 - Occurring More frequently
 - Also see jack height issues.....too high
- Plug Tolerances
 - Plastic where it should not be
 - Out of Spec Dimensions
- Bad Plug Terminations
 - Blade Depth Issues
 - Cupping and Bowing Due to worn out tooling
- Out of Spec Mold Drafts
 - Internal to the Jack Creates “Play” after insertion
 - Use of Brass (cheaper) as the base metal (instead of Phosphor Bronze) increases the resistance and affects electrical and mechanical performance

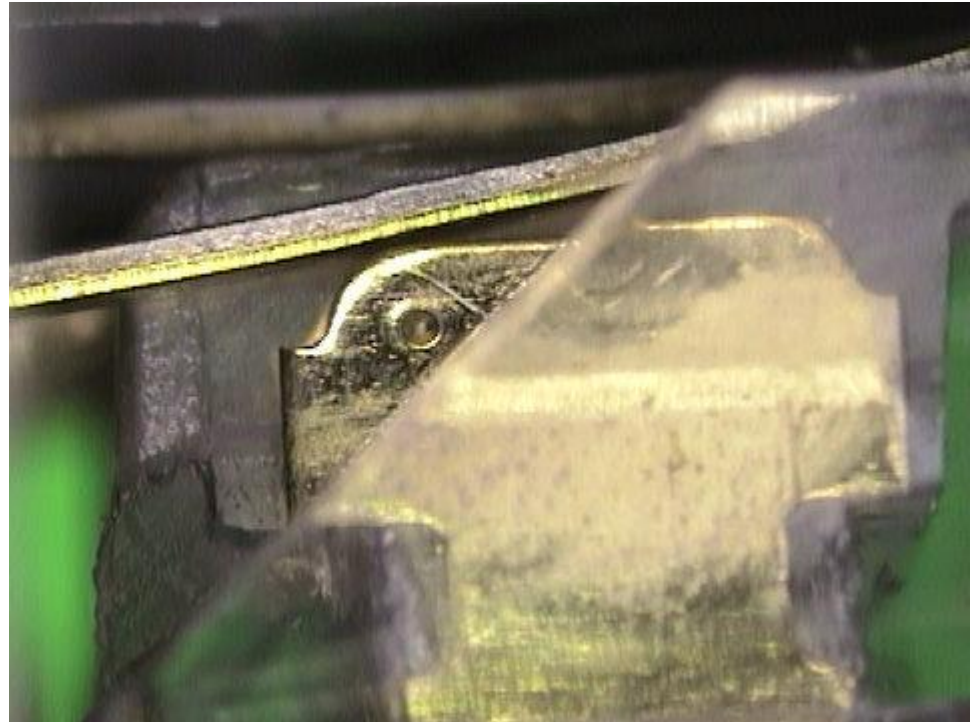
Our Analysis of the Switch

We are hearing about this more and more. Basically, the RJ45 Jack on the Switch is TOO WIDE.

This causes the plastic of the plug (between the contacts) to 'LIFT OFF' from the jack contact resulting in Loss of Signal or Intermittencies.

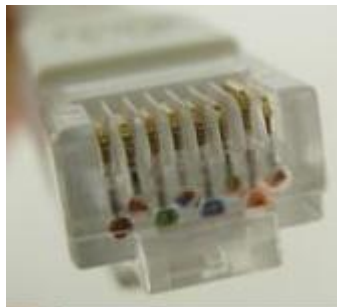
.237" +/- .005"

Seeing More and More Blade Depth Issues

2nd Contact From Right
Taken from CI&M Article

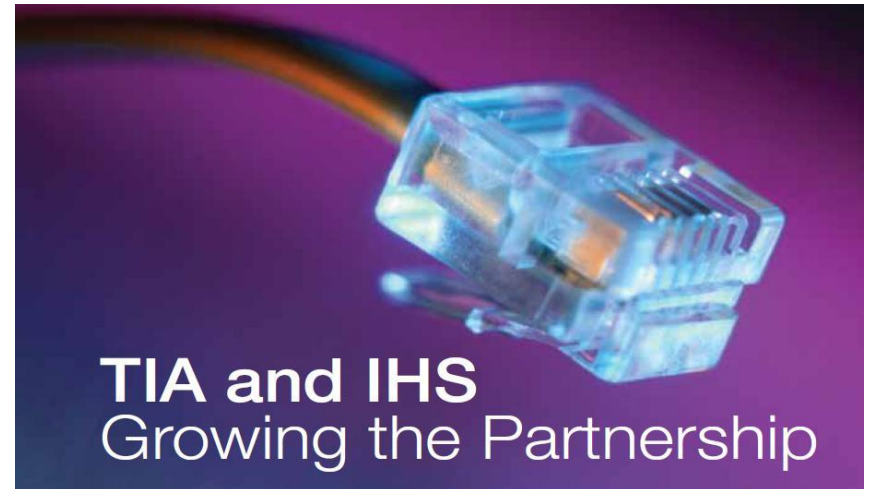
1st Contact on the Left
Taken from The Star Report - 2011

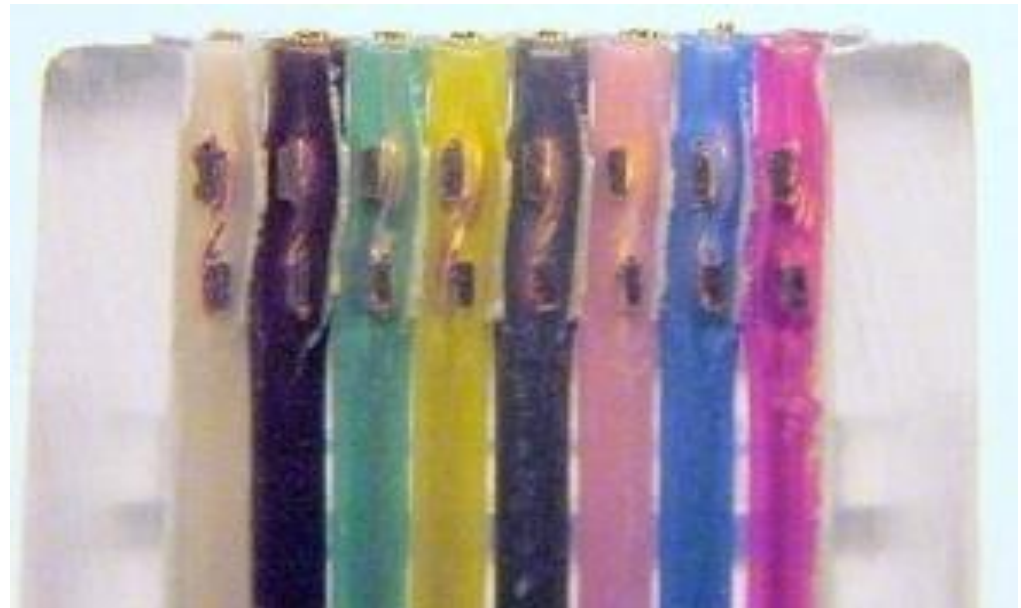
Plug Contact (Blade) Design Issues

Some manufacturers offer a contact design for solid conductors and a different blade design for stranded conductors.

The blade for stranded conductors will pierce the insulation **STRAIGHT DOWN**, instead of straddling the conductors.

By specifying the wrong blade design, you can actually **FRACTURE** the **SOLID** conductor.

Improper blade design can also **PUSH** the conductor to one side or the other creating a **HOT SPOT** (important later).

CONDUCTOR BUNCHING exacerbates the situation. making plug selection **CRITICAL** for the cable used.

- Good Design Shows Blade “**STRADDLING**” the **CONDUCTOR**....Forms an “**S**” Curve
- Can be Used with either **SOLID** or **STRANDED** Conductors

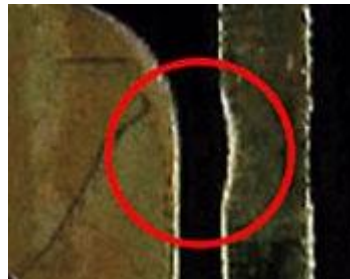
Jack Contact Design Issues (3)

- You should not be seeing this type of contact wear. The plugs and jacks were designed so that the wear would occur on the PLUG SURFACE, NOT THE JACK SURFACE. Why....it is easier to replace the cord.
- This is due to the imperfections of the plating on the plug (burrs, rasps, ridges) causing the friction to rub off the plating on the jack.
- When built according to all specs, you should see an “INVERTED RESISTANCE CURVE”, whereby the plug contact surface is actually “POLISHING” the jack contact surface. You get better resistance characteristics through approximately 350-400 insertions, then the resistance begins to deteriorate.
