Optical Fiber Cable Design & Reliability

Patrick Van Vickle, Sumitomo Electric Lightwave

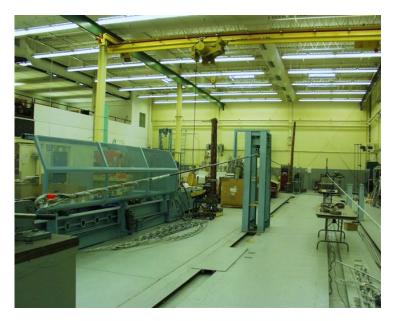
DriTube Ribbon Design

• Aeolian & Galloping Vibration (IEEE 1222)

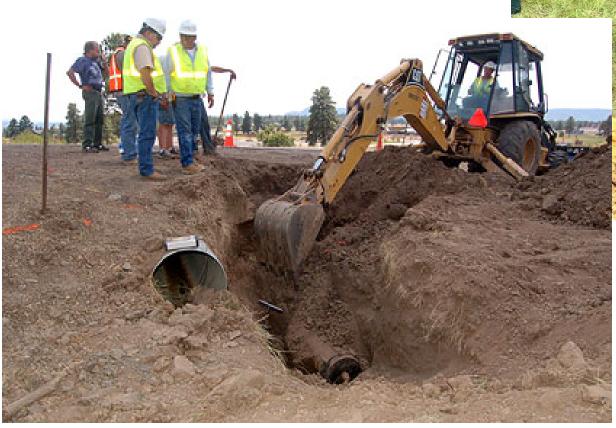
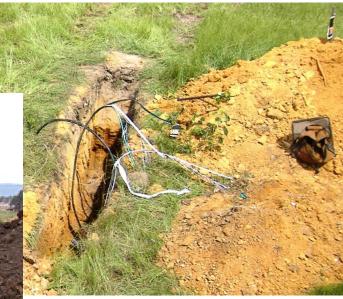
Cable Dig-Up

- Mechanical Damage
 - Wind Loading
 - High Tensile Installation
 - Dig-ups
- Environmental Damage
 - Water Penetration
 - Freezing
