# Insertion / Return Losses vs. Temperature Performance of RTPGE Cable Assemblies

Sasha Babenko

Mike Gardner

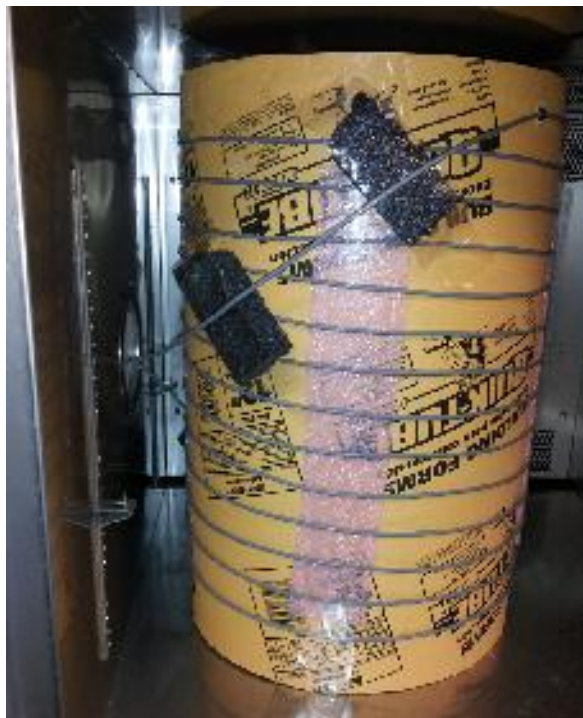
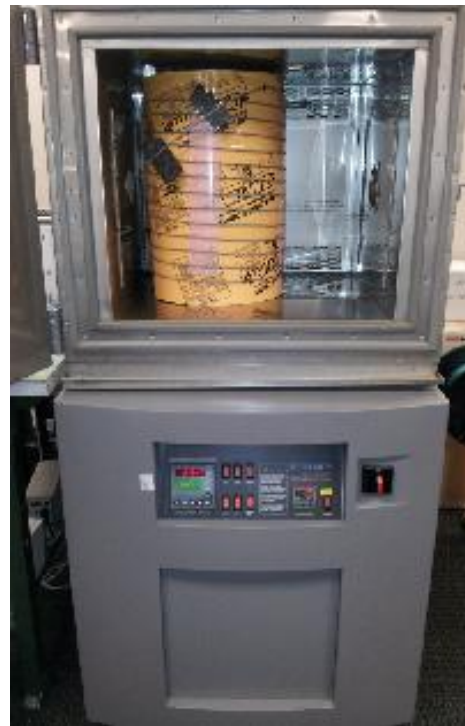
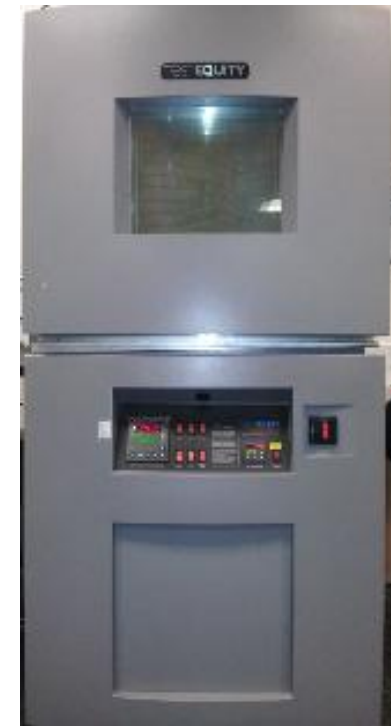
Drum with cable assembly and the thermal chamber:

We have used a cardboard drum 12" diameter (30.5 cm) that allowed each wrap of cable to be ~1m. This allowed us to test up to 15m links in a chamber that is 24" W\_21" H\_24" D.

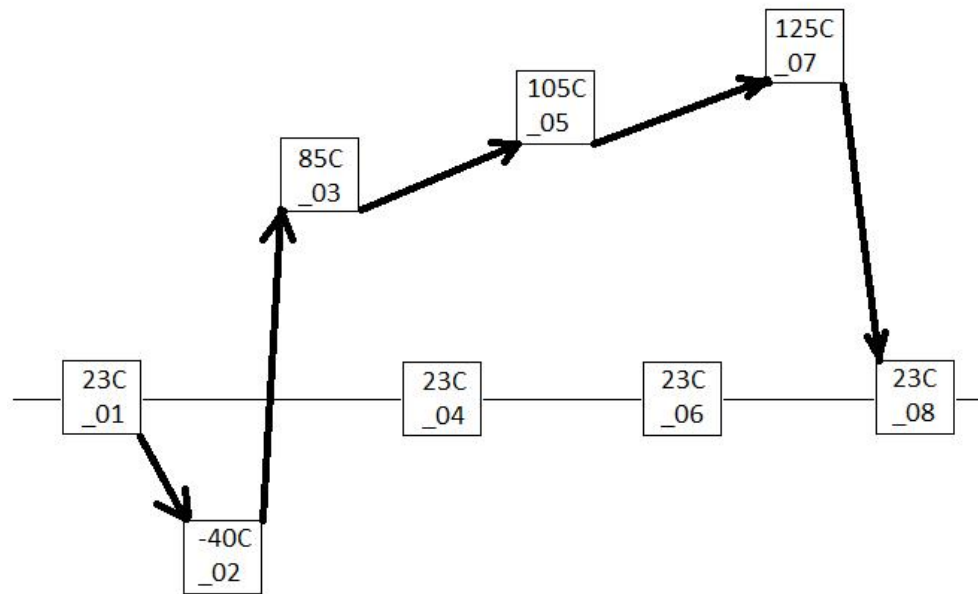
Second sequence had only 6 steps as outlined below (\_01, \_02, \_03, \_05, \_07, \_08) with their respective temperature settings. After it was proven using the first test sequence that extreme temperatures do not permanently degrade the IL/RL, second more streamlined sequence was used where 23C measurements \_04 and \_06 were skipped.

Two entire channel assemblies were tested using this sequence.

Data for each step 01 through 08 is identified with “\_01 ... \_08” for easier tracking of test results.

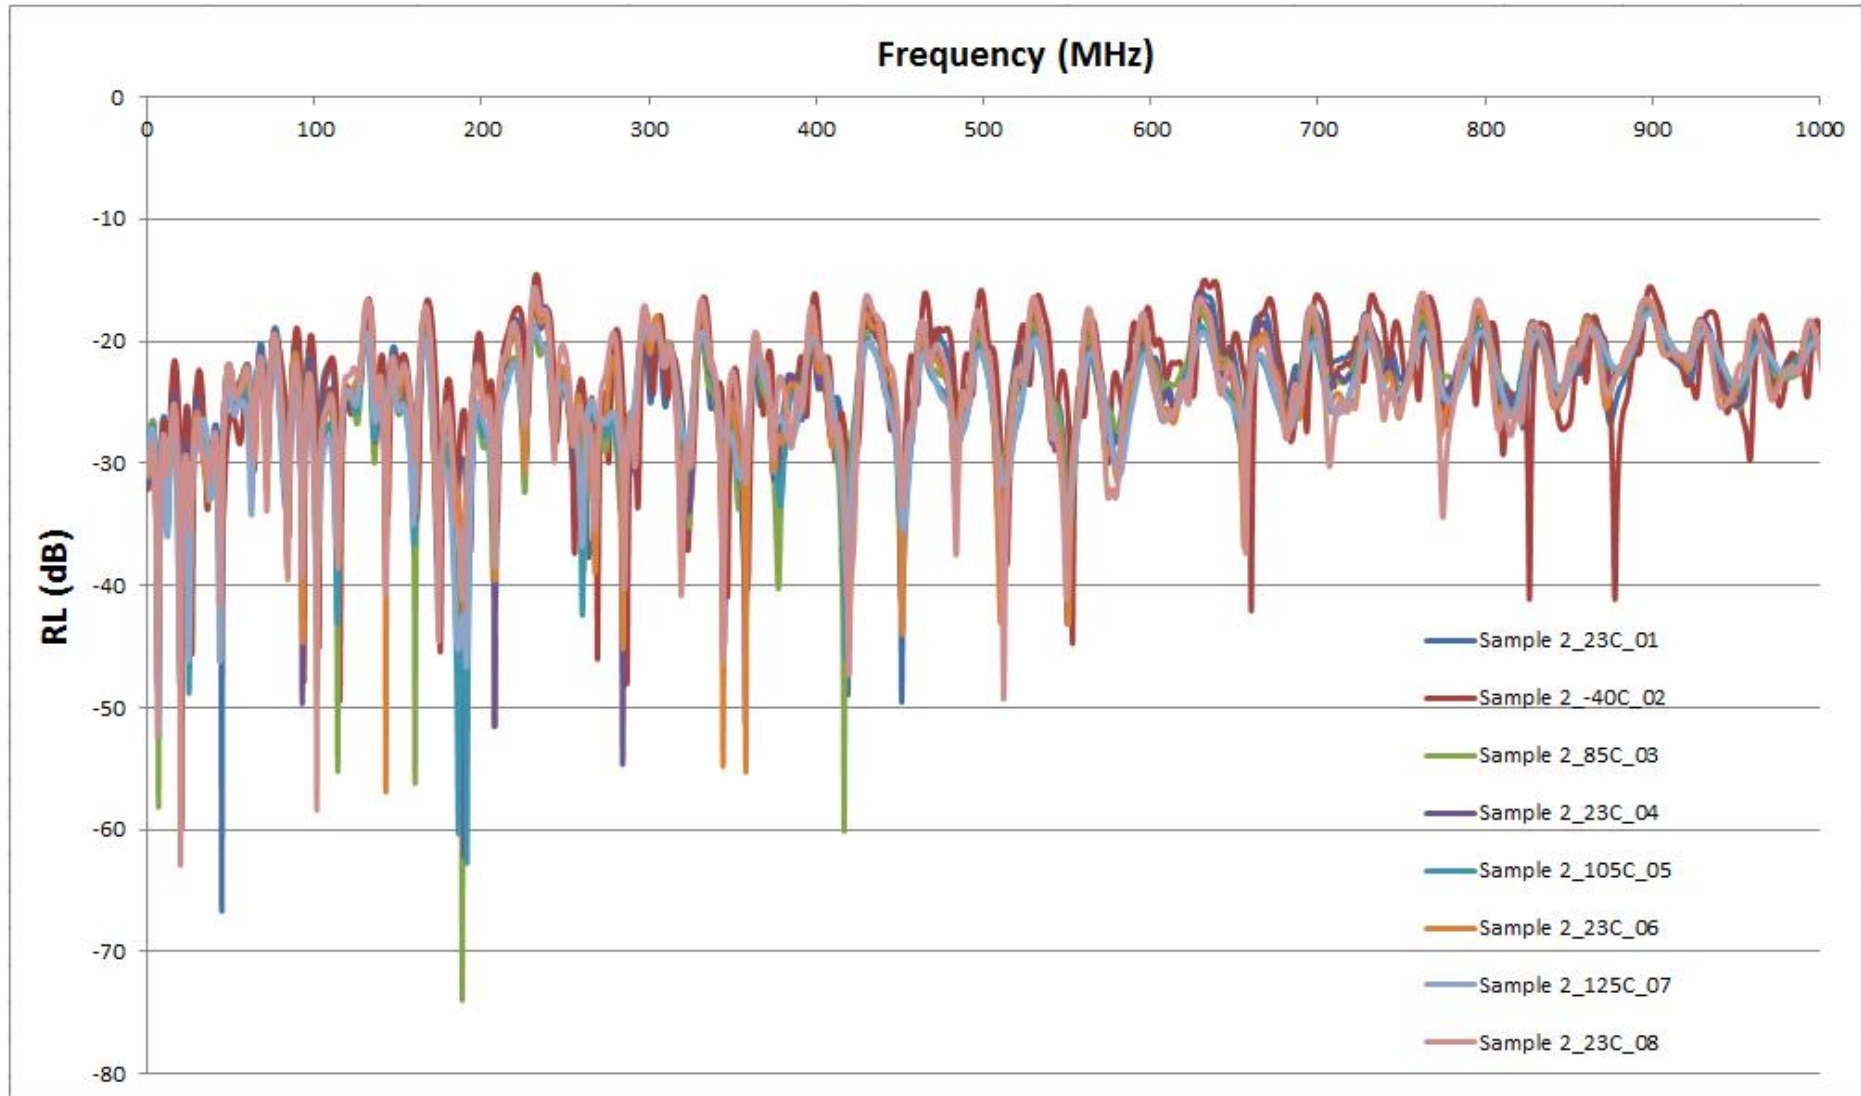
Sample 2 – 22 awg PP/PVC (0.34mm<sup>2</sup>)\_15m\_five 3m links\_4 inlines\_Cable A\_Connector 1

- › There appears to be no permanent degradation of IL/RL after extreme temperature exposure (long-term thermal cycling / shock studies would be needed to fully verify this)
- › Higher temperatures definitely degrade IL/RL performance and this must be taken into account during limit selection and later during production and system implementation
- › Special attention must be paid to raw cable performance (dielectric material properties play a big role in assembly performance)
- › In-line connections and untwist of diff pairs around end connectors and in-line connectors may create noticeable resonances (periodic IL suck outs / dips)

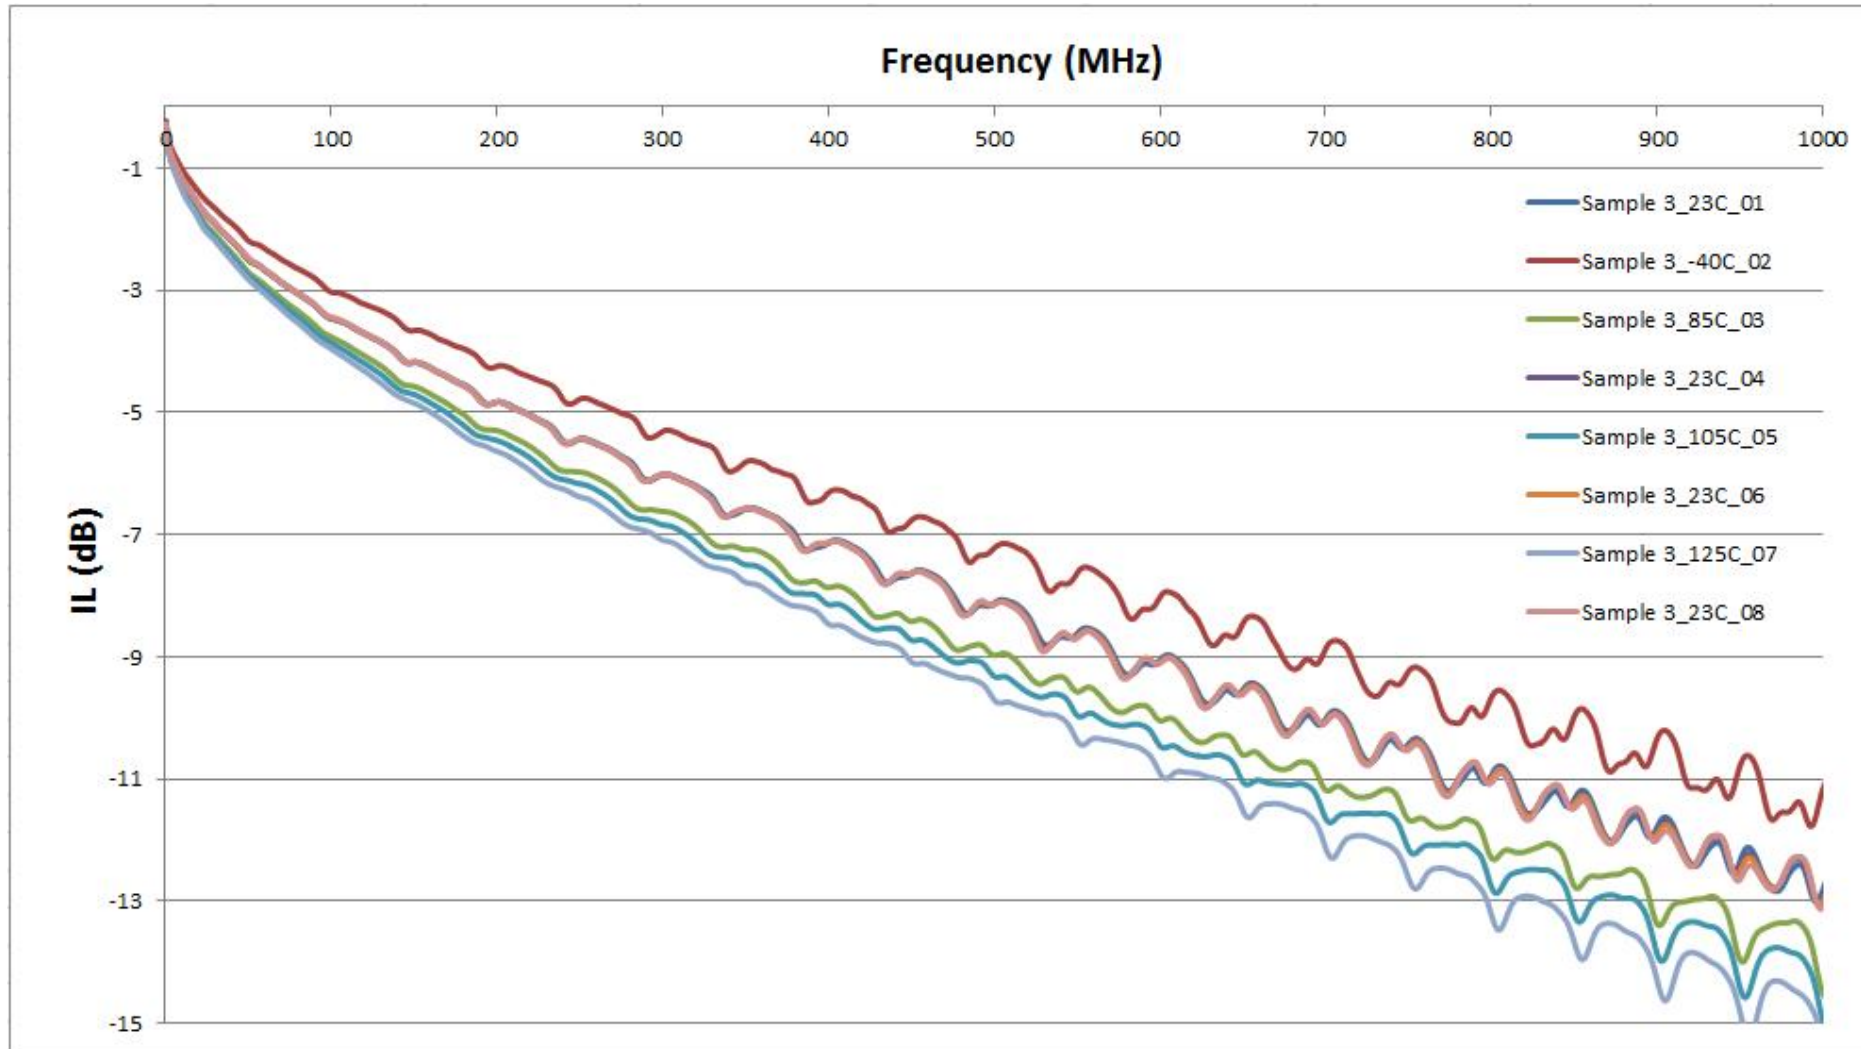
Sample 3 – 28 awg PP Shielded (0.08mm<sup>2</sup>)\_10m\_five 2m links\_4 inlines\_Cable B\_Connector 1

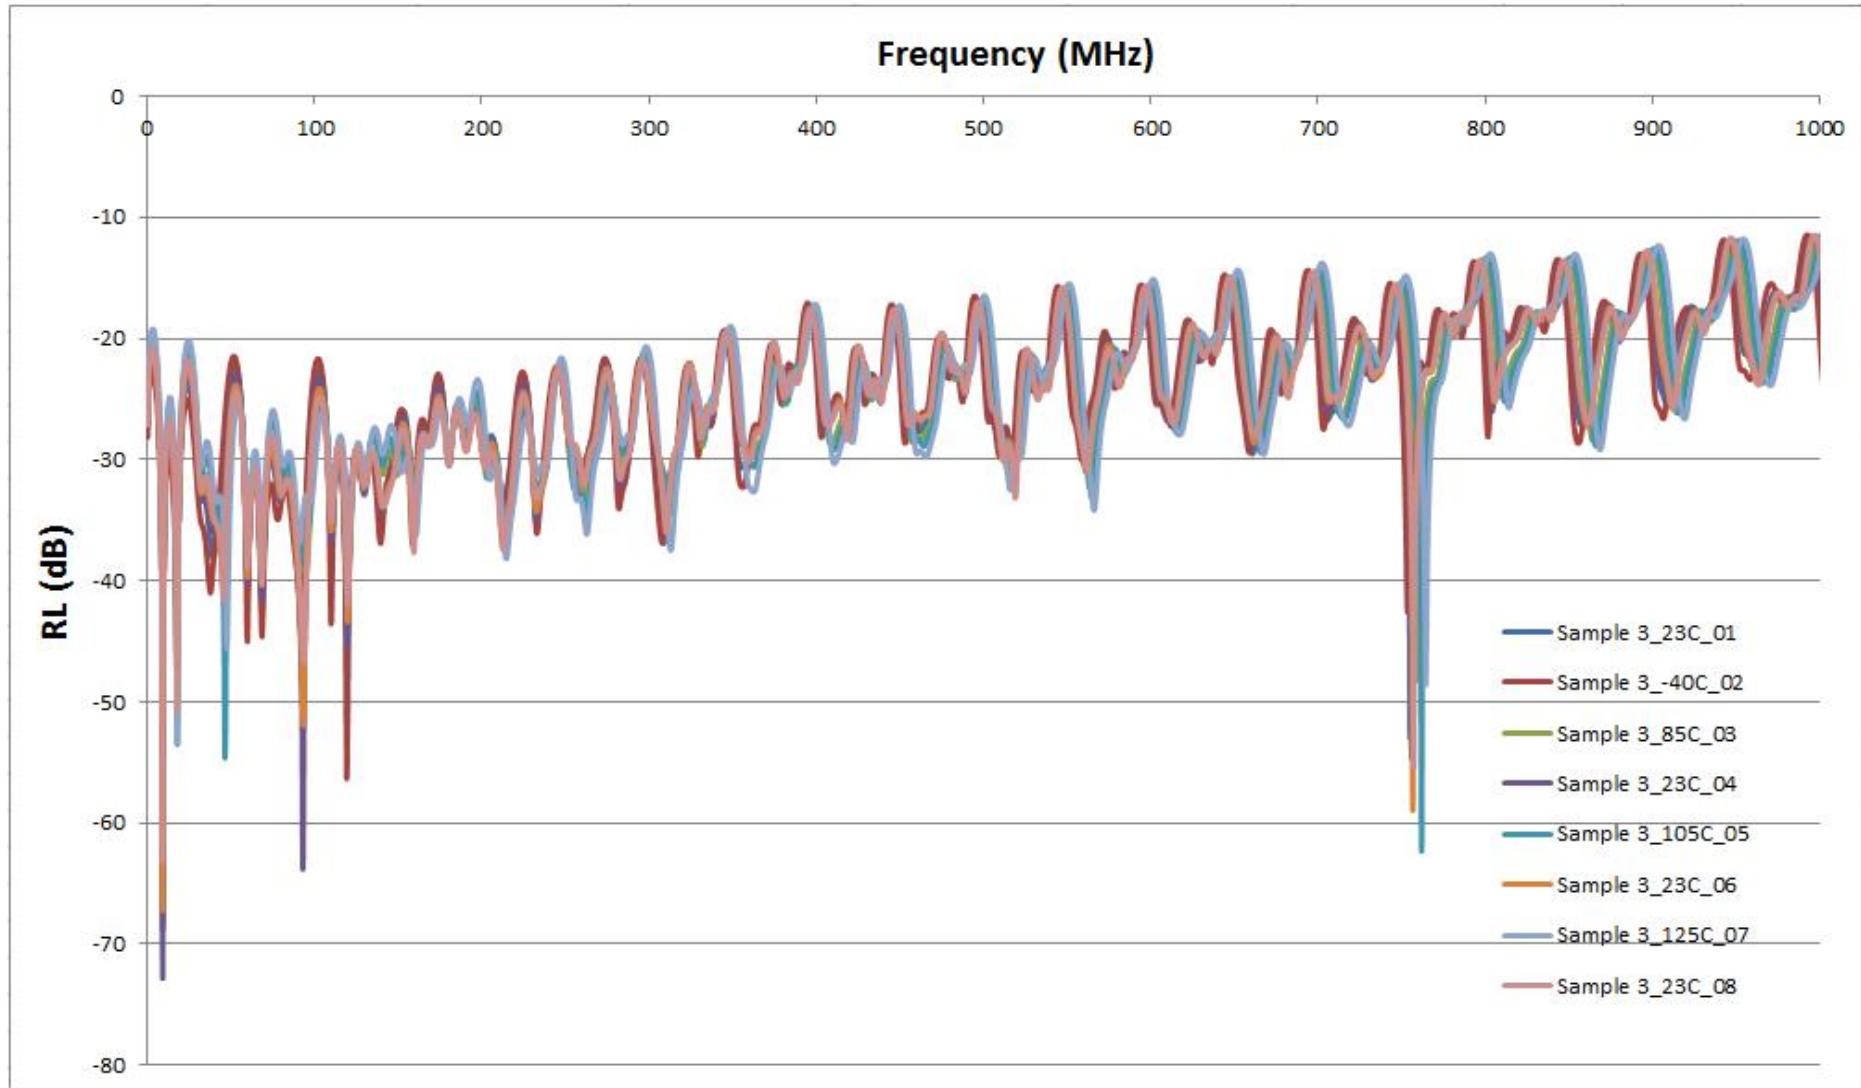
Sample 3 – 28 awg PP Shielded (0.08mm<sup>2</sup>)\_10m\_five 2m links\_4 inlines\_Cable B\_Connector 1

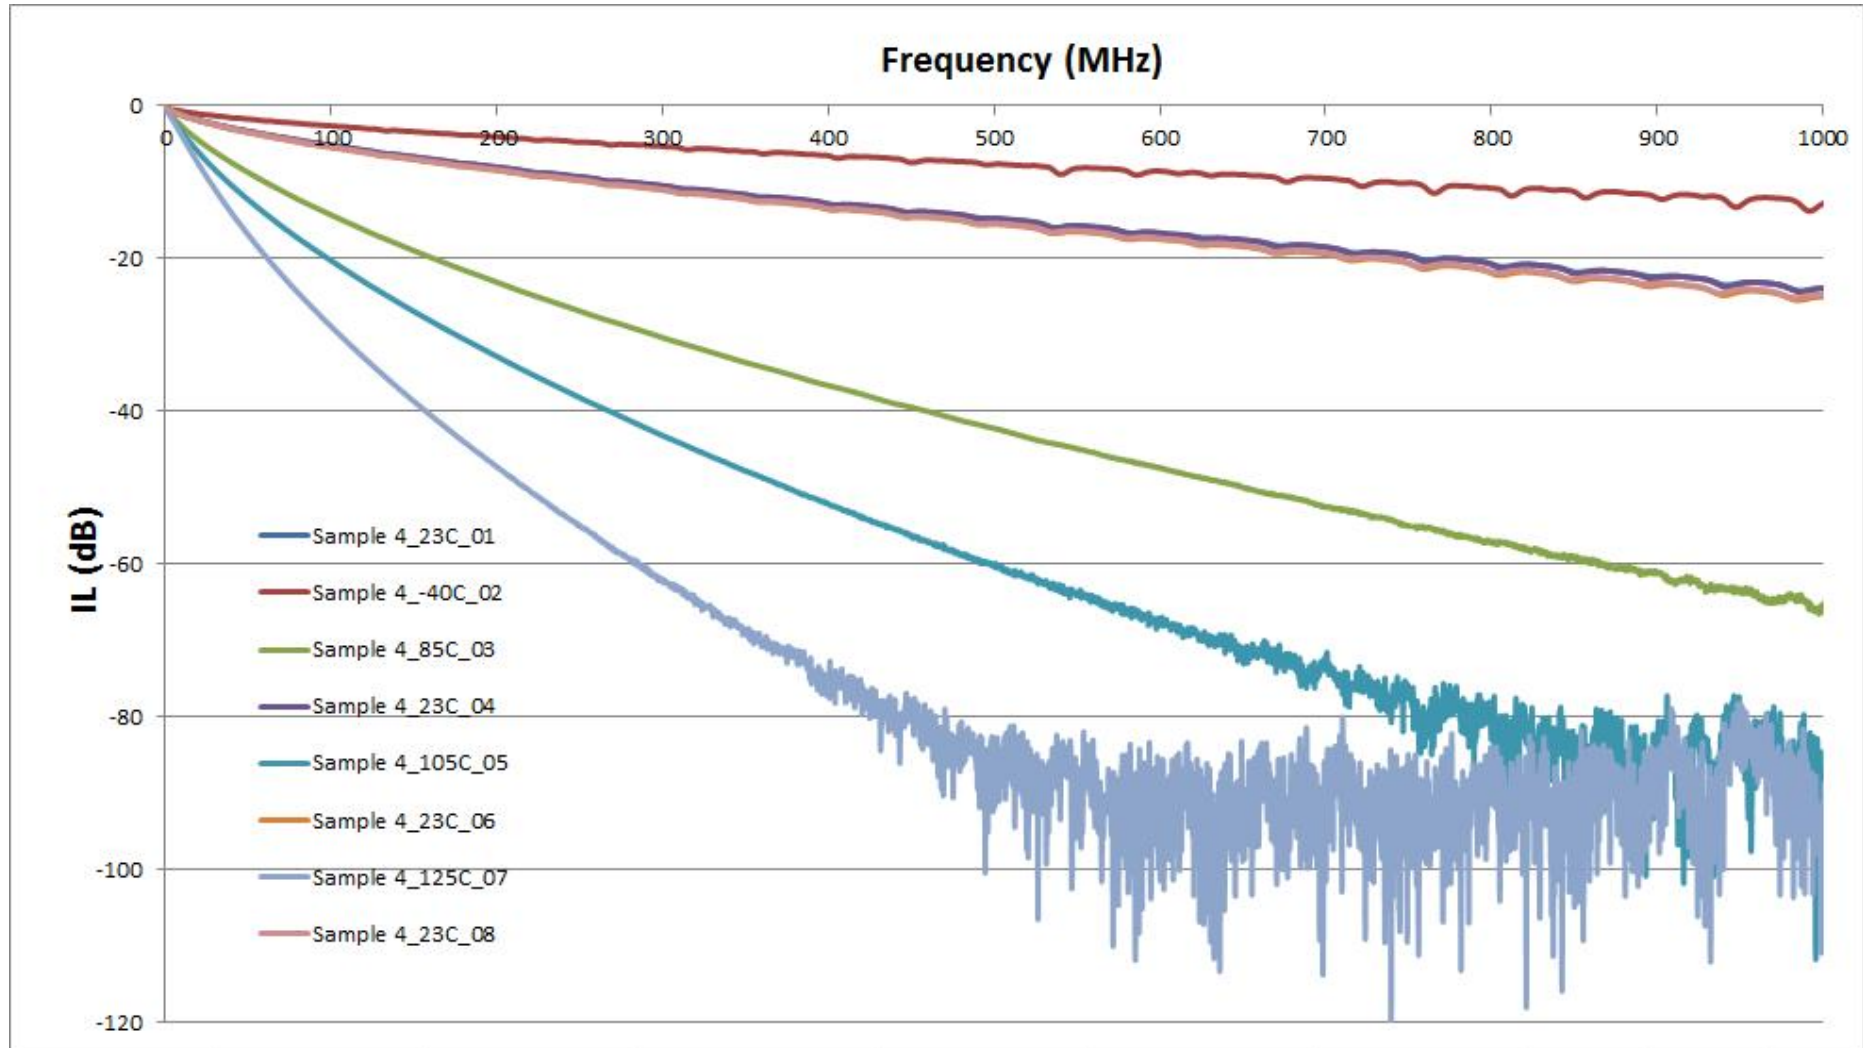
Sample 4 – 25 awg PVC/PVC (0.18mm<sup>2</sup>)\_10m\_five 2m links\_4 inlines\_Cable C\_Connector 1

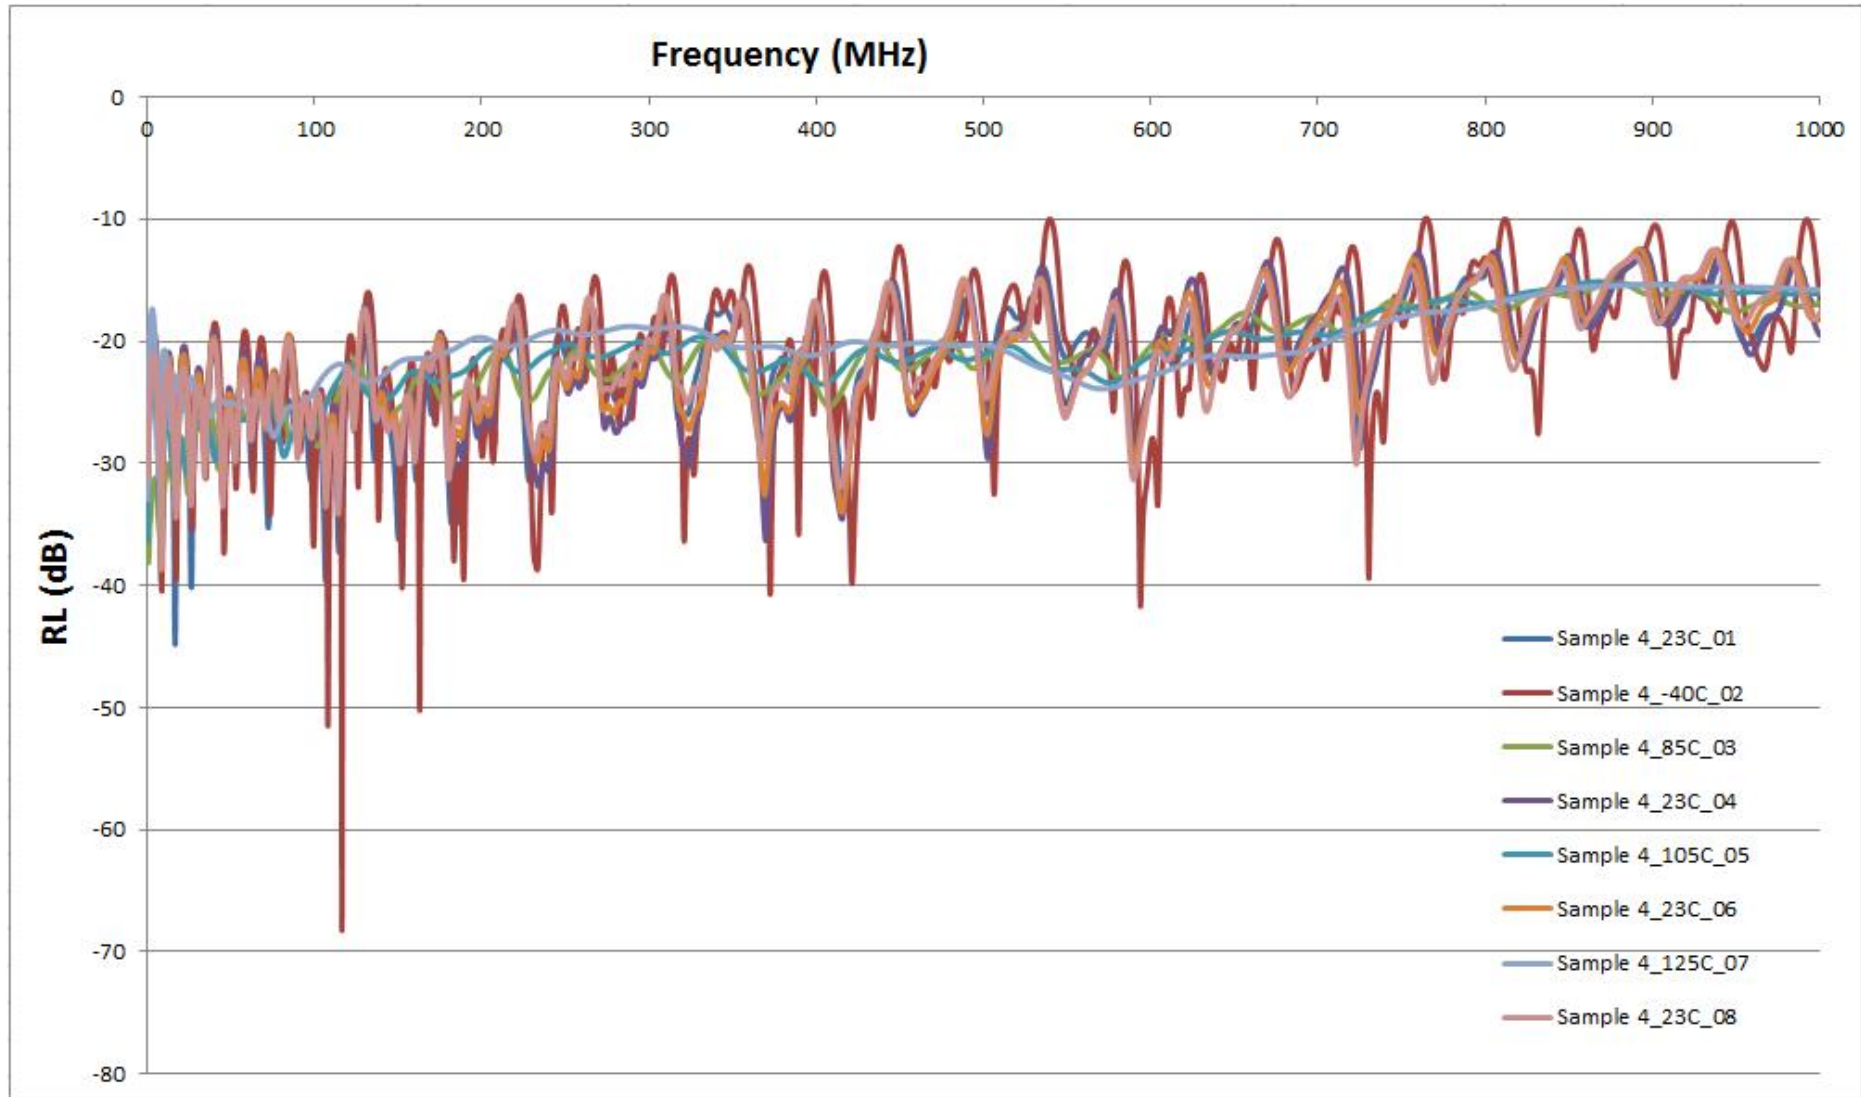
Sample 4 – 25 awg PVC/PVC (0.18mm<sup>2</sup>)\_10m\_five 2m links\_4 inlines\_Cable C\_Connector 1
