802.3da Verification of Consensus Model Simulation

Stephan Schreiner, Thomas Müller
Rosenberger Hochfrequenztechnik GmbH & Co. KG

12th July 2023

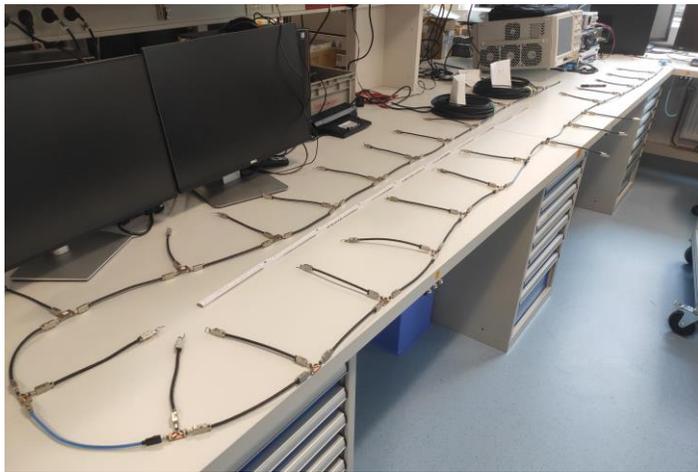
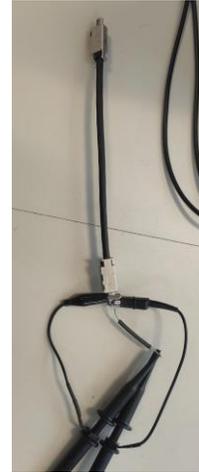
Discrete capacitance

Dummy Node:
