Overview of Technical Report Presented to IEC SC48B committee

Durability of Connecting Hardware under Electrical Load for Power-over-Ethernet Applications

TECHNICAL COMMITTEE No. 48: ELECTROMECHANICAL COMPONENTS AND MECHANICAL STRUCTURES FOR ELECTRONIC EQUIPMENT

SUB-COMMITTEE 48B - connectors

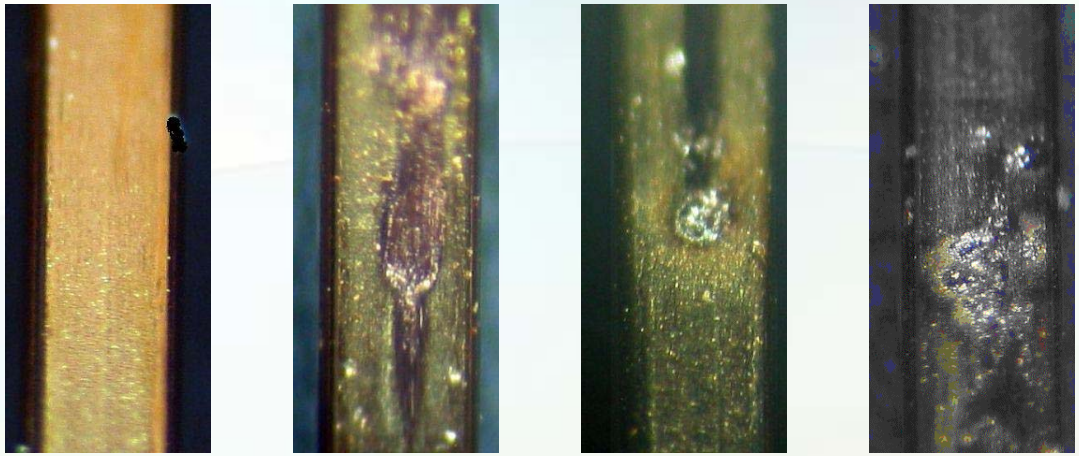
Figure 3. Connecting Hardware Contacts

A) Fresh unused
B) After mechanical cycling without electrical load
C) Crater caused by a spark
D) Multiple craters due to discharges

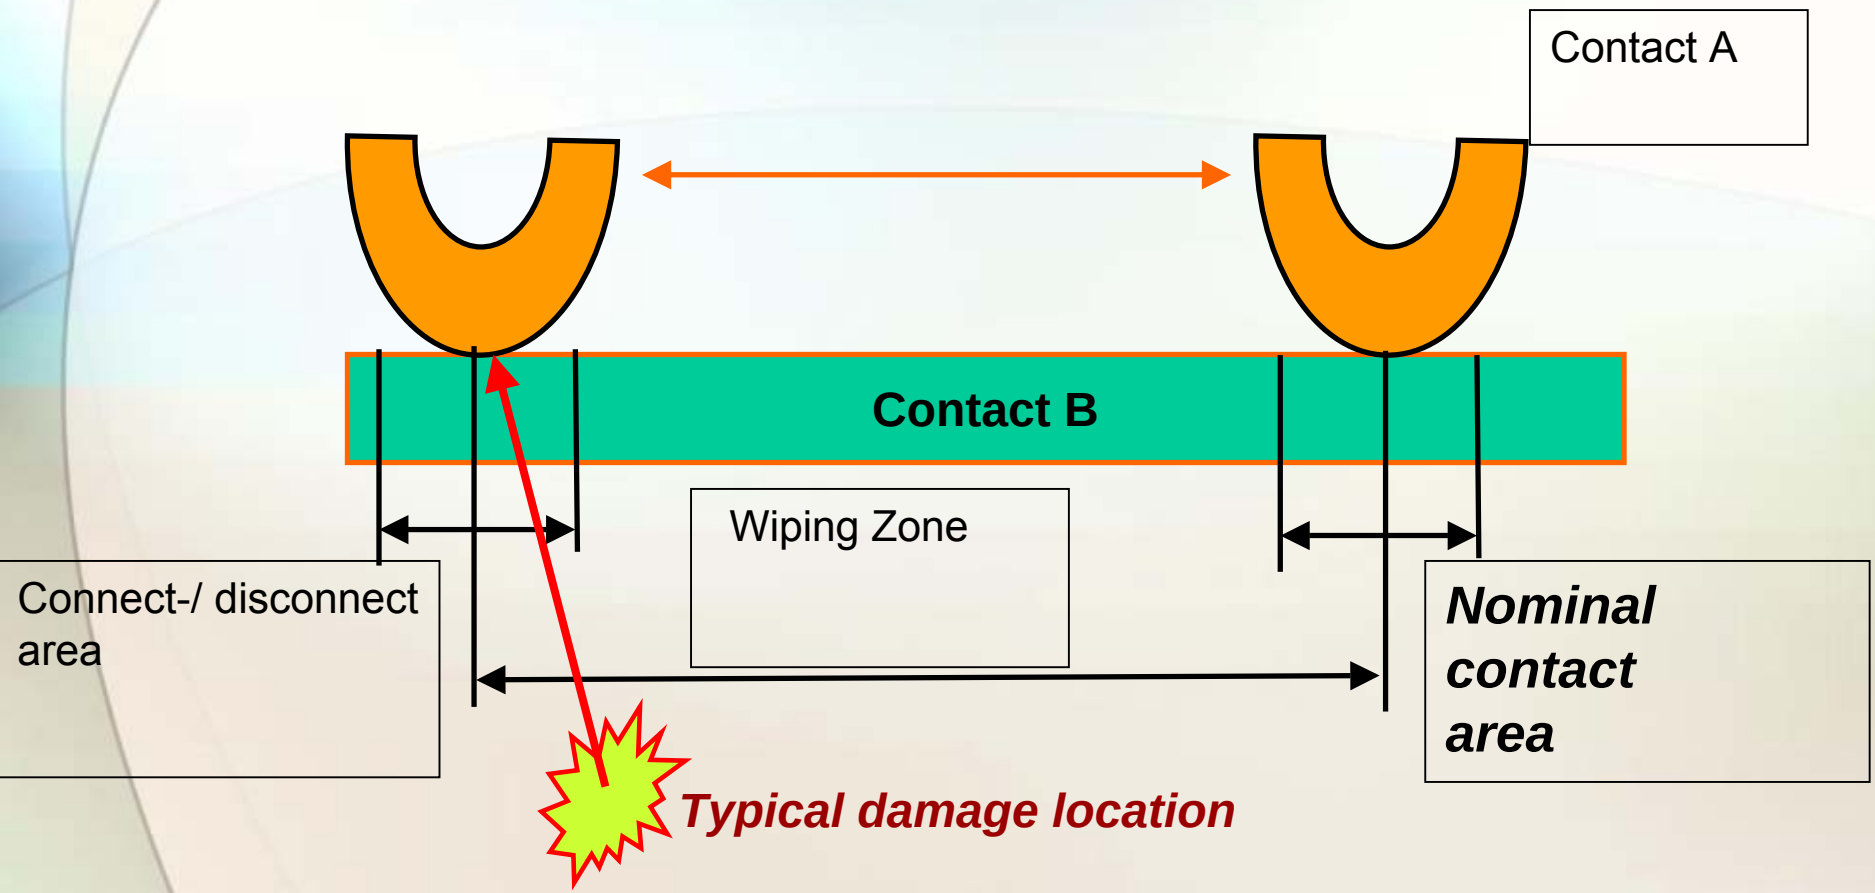
Typical effect of Electrical Discharge in connectors

Connector Wiping Zone

SPARK CRATER located outside of ***nominal contact zone***

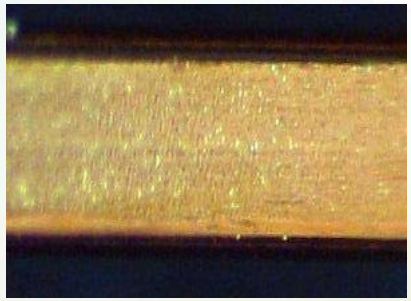
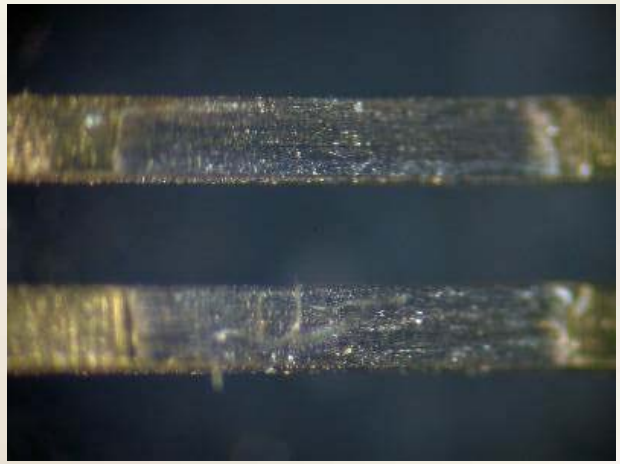
Tests 1A and 2A

RJ45 fresh Contact

After 750 mechanical Cycles no el. load

ARJ45 fresh contact

ARJ45 after 750 cycles no el.load

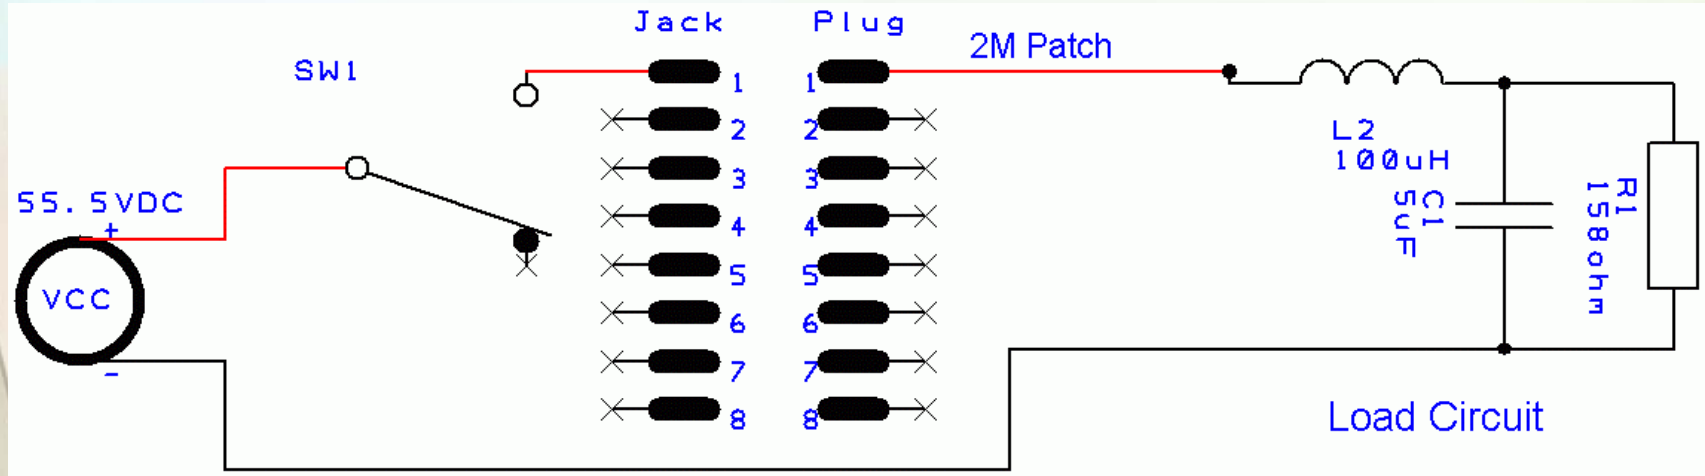
Test Circuit A

Tests 3A

Objective of this test was to identify parameters of the expected LLCR changes and variations in the LLCR during the unmating cycles only. The power was 20 W per contact. The LLCR was measured initially and after each 80 cycles, using a separate measuring plug. A total of 800 cycles were performed.

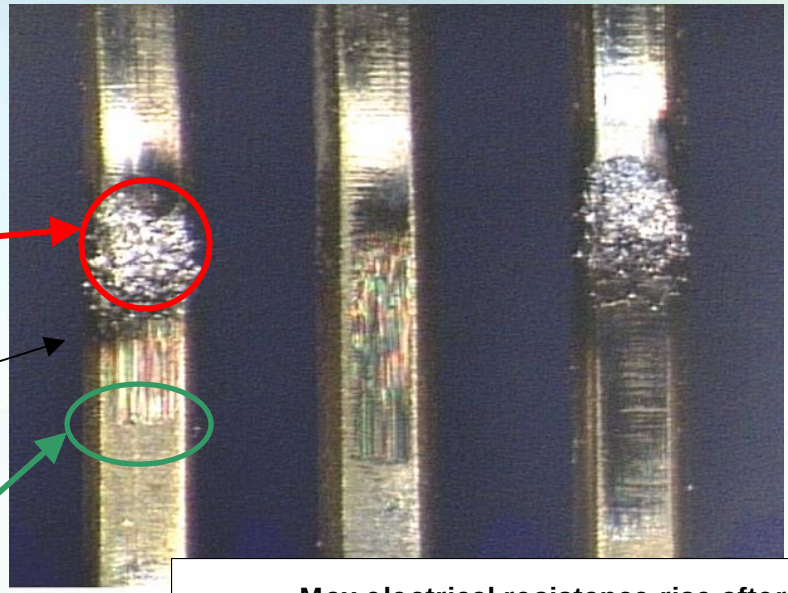
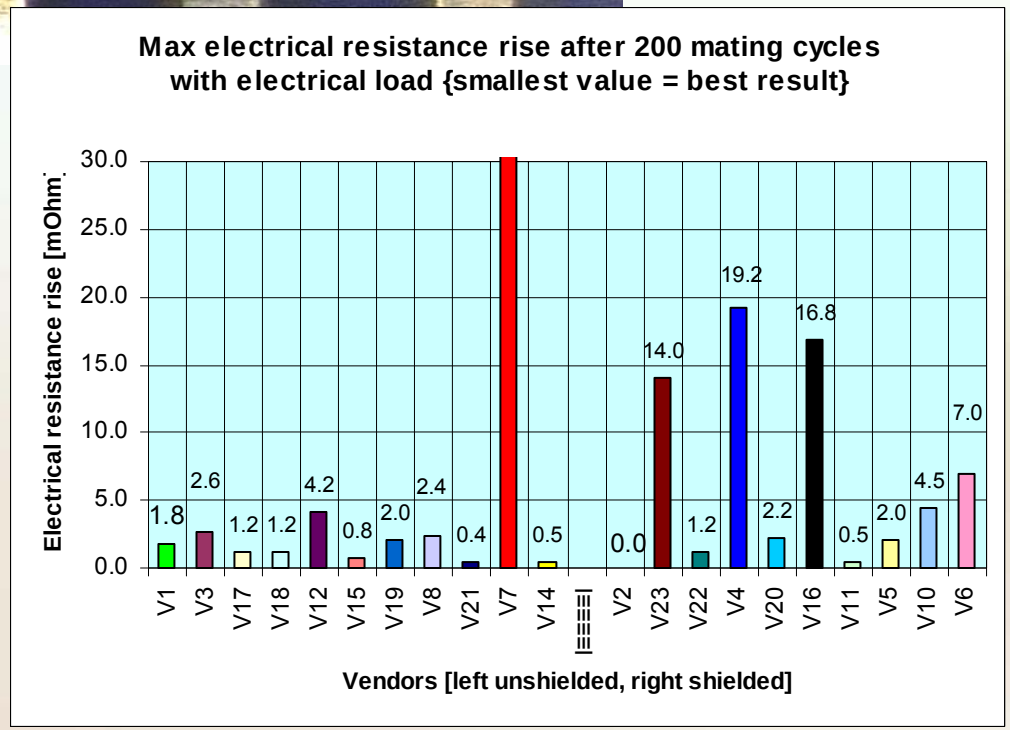
<u>Test 4A: Comparison of different RJ45's with proposed SC25 WG3 requirement</u>

Proposed by SC25 WG3 during the development of the ISO/IEC 11801 2nd Ed: assumed extra voltage of 50% over 48V and the supposed worst case scenario, that when the contacts of the jack do ***not*** open simultaneously, the power of 12.6 W has to be covered by one pair only.
The charging power was present during mating and unmating.

Test 4A. 23 test specimens manufactured by Chinese, European and US suppliers, Shielded and Unshielded

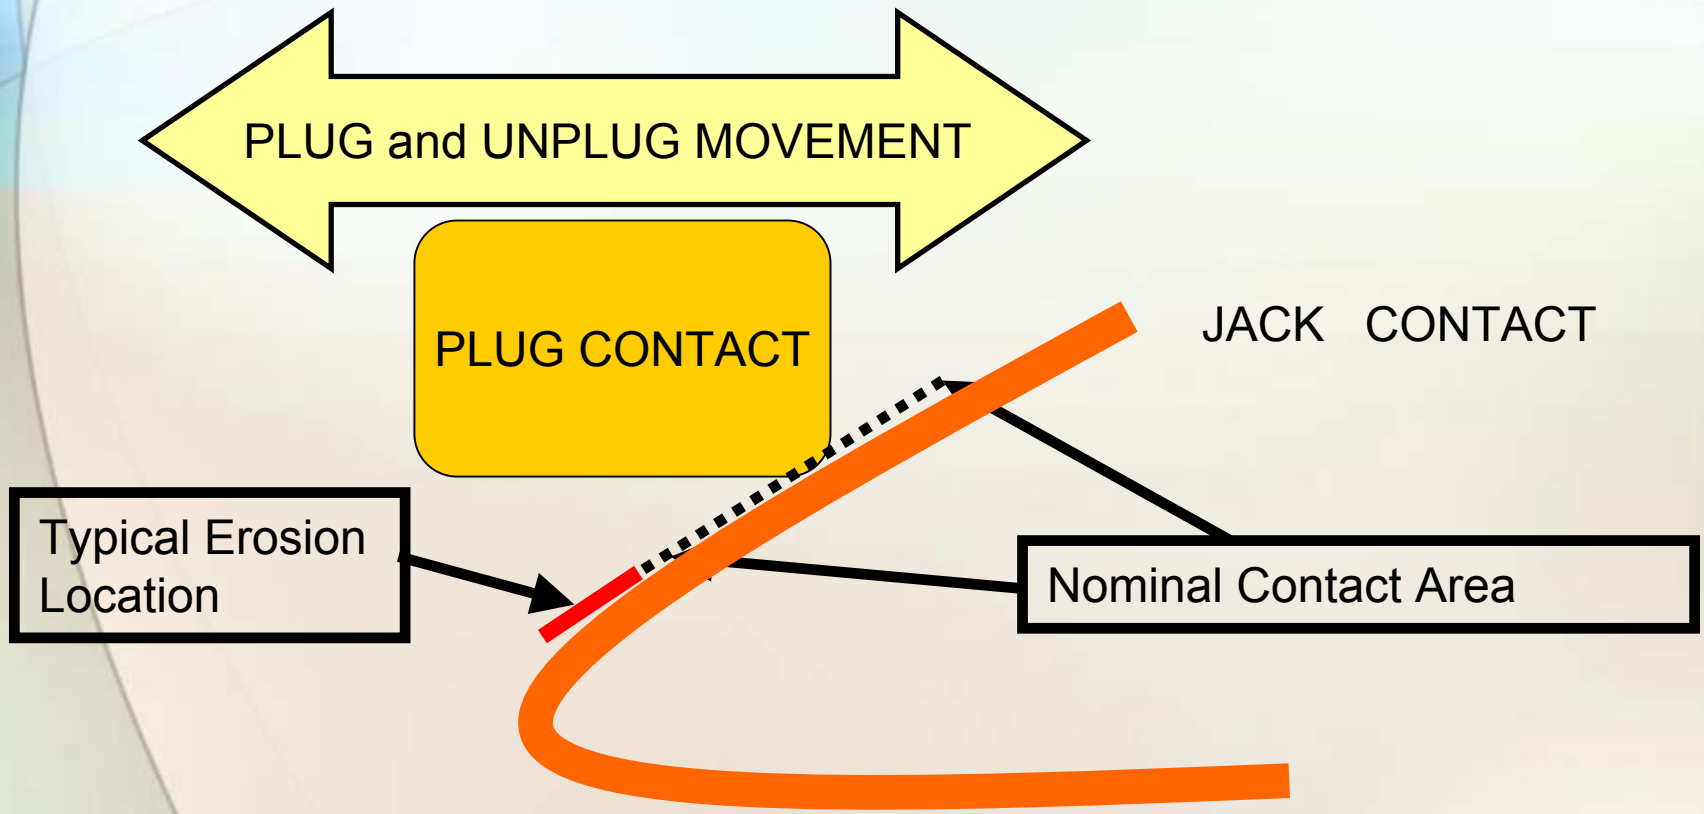
PoE PLUS. CONNECTOR DURABILITY UNDER ELECTRICAL LOAD

LOCATION of EROSION TYPICALLY OUTSIDE OF NOMINAL CONTACT ZONE (WIPING ZONE)

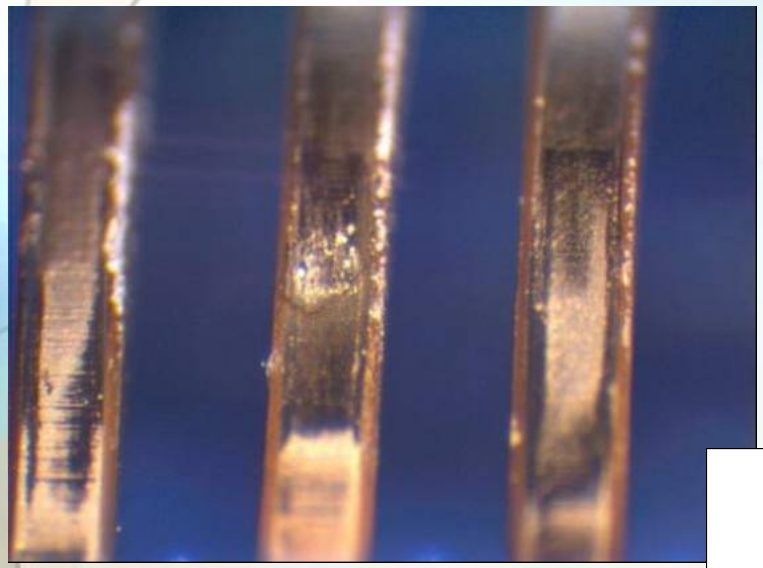
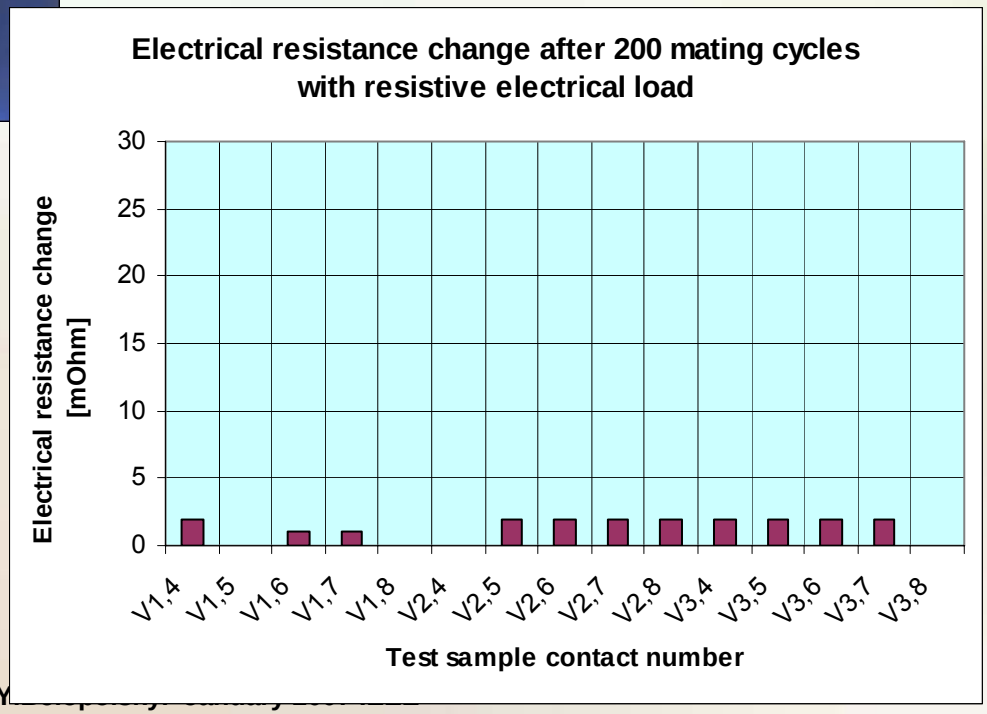
Test 5A results:

Test with resistive load resulted in very little damage to contacts and negligible change in LLCR- irrespective of the connector manufacturer

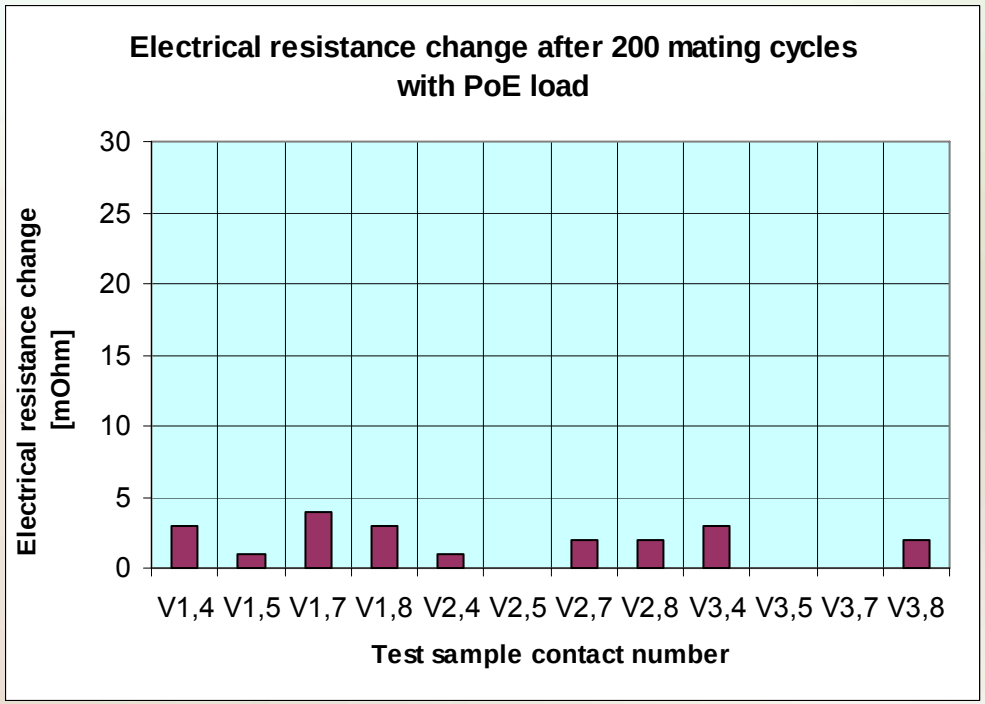
Test 6A results:
Power interruption using PoE equipment did not cause any failures or significant damage

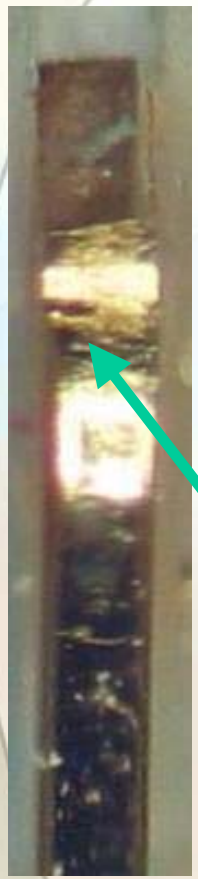
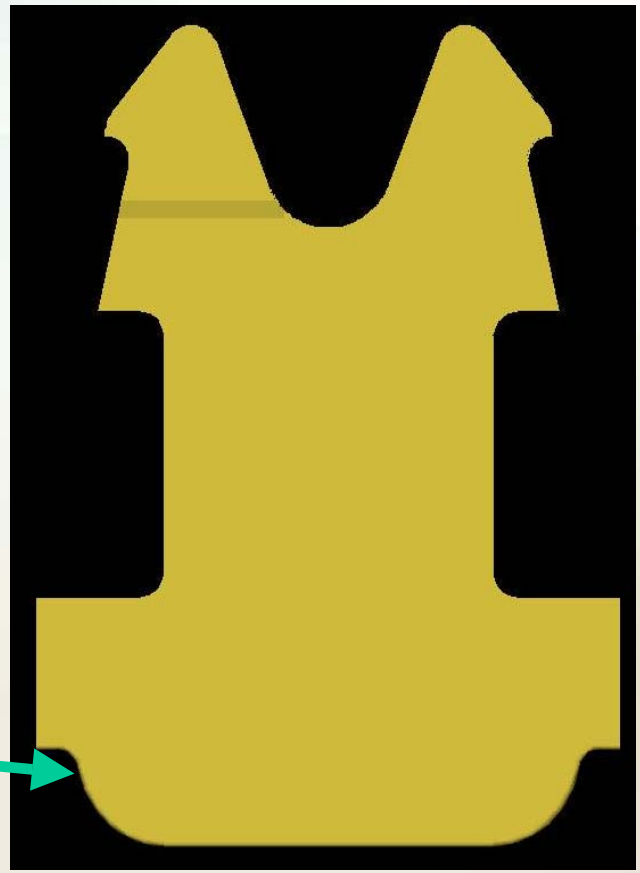
Test 12A: effects of polarity

PLUG CONTACT

Typical Erosion Location
Outside nominal contact area

Damage was small in comparison to jacks. Two possible factors:

a) jack contact experiences simultaneously a mechanical stress (bending) and electrical discharge leading to greater observed damage

b) that the thermal mass of plug contact is greater in the discharge area

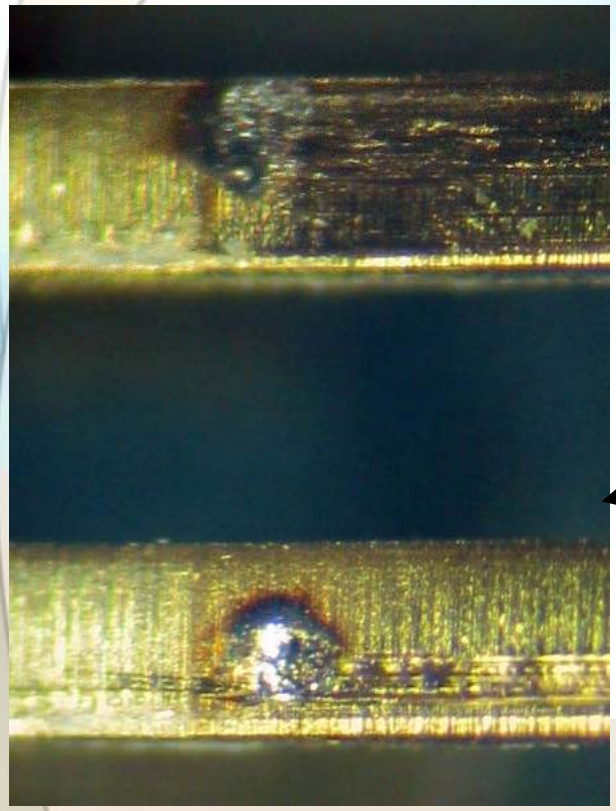
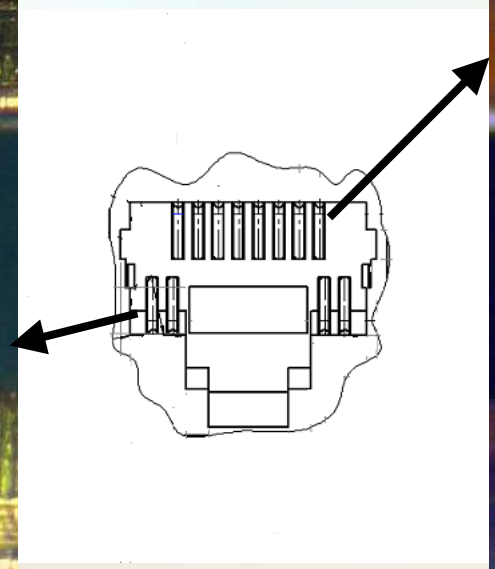
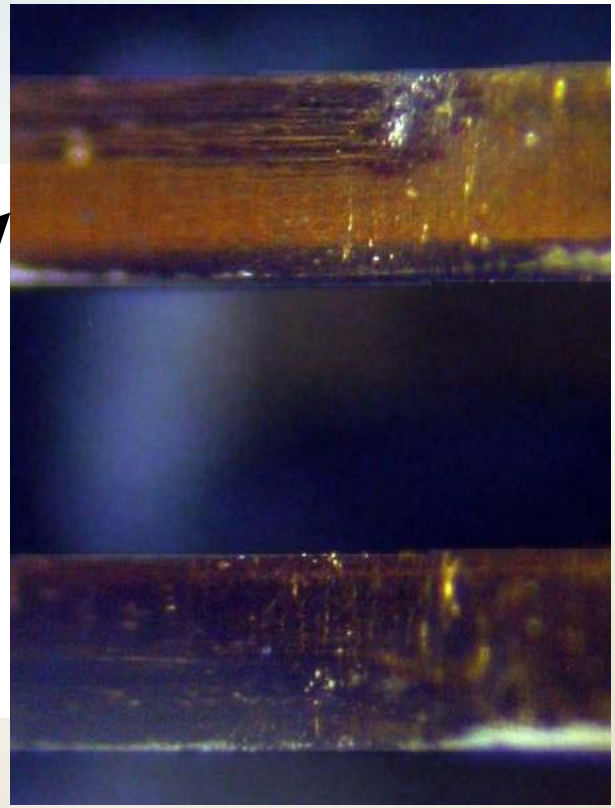
ARJ45 Category 7
Bottom contacts

Discharge effects in the area peripheral to contact area

Very little or no visible discharge effects

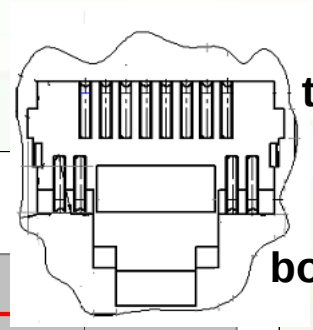
Change in Bulk Low Level Contact Resistance combined for all groups for ARJ45 HD connectors

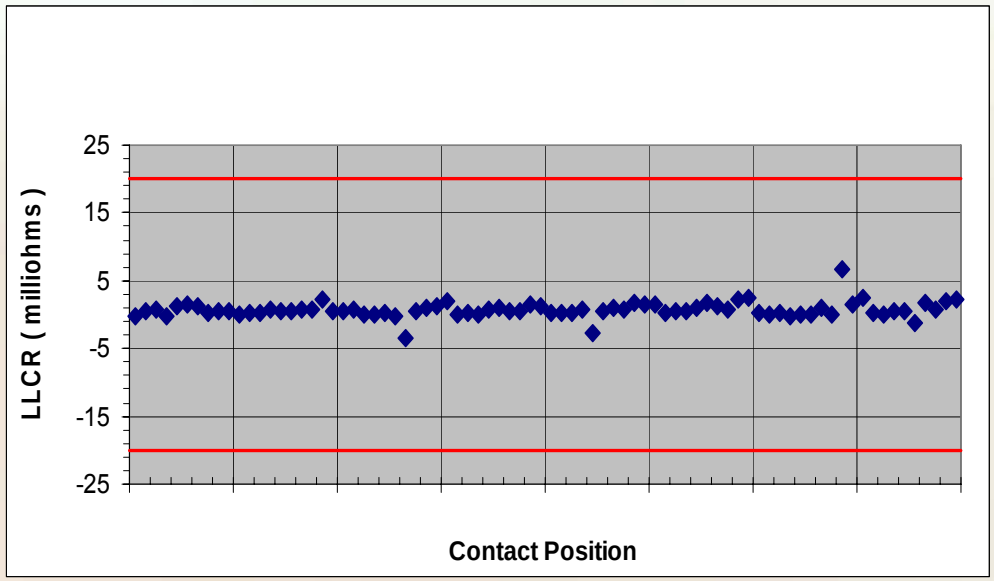
Tests 14A and 15A. 100-meter long cable test

There was no degradation in the LLCR exceeding the specified limits.
