## Revised Receive State Diagram Figure 24-11a

IEEE 802.3az Task Force Chicago, Sep 2009

Realtek Semiconductor Corp.

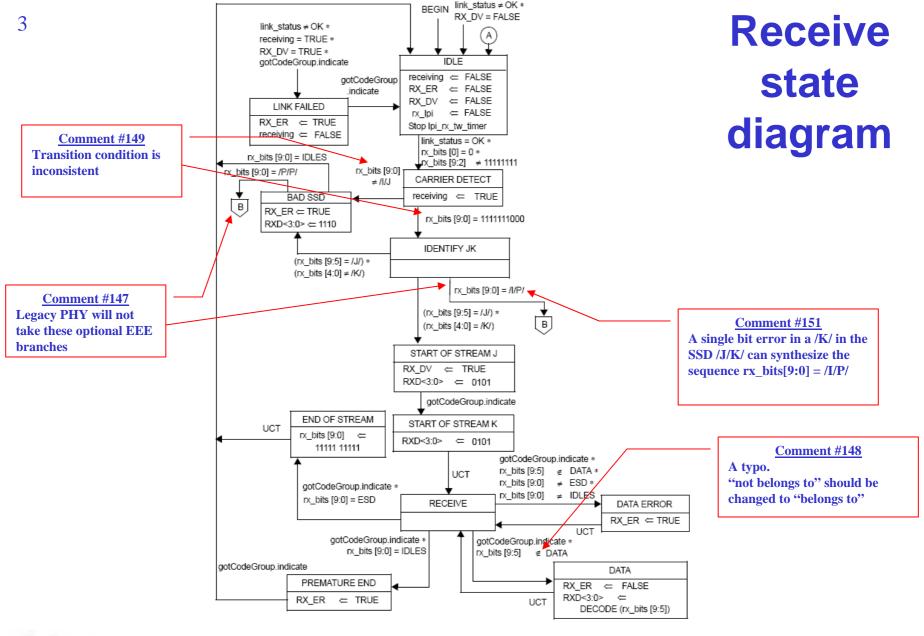
Figure 24–11a—Receive state diagram, part a

- ☐ Modify Receive state diagram (Fig 24-11a) of Clause24 to respond to the following comments:
  - ➤ Comment 147 : Legacy PHY will not take these optional EEE branches.
  - ➤ Comment 148: There is a typo in the original diagram. "not belongs to" should be changed to "belongs to".
  - Comment 149: Why is "rx\_bits[9:0] {equal to} /I/J/ " changed to "rx\_bits[9:0] {equal to} 11111111000 "?
  - ➤ Comment 151 : A single bit error in a /K/ in the SSD /J/K/ can synthesize the sequence rx\_bits[9:0] = /I/P/. In the "classic" 100BASE-X receive state machine, this would be counted as a BAD SSD,

- □ Introduce a new state WAIT\_SLEEP between IDENTIFY JK and branch point "B" which goes to START RX\_SLEEP
  - ➤ The receiver moves to WAIT\_SLEEP from the state IDENTIFY JK when a bit pattern 1111100000 is received.
  - ➤ It then moves to START RX\_SLEEP when receiving two consecutive SLEEP symbols, /P/P/.
  - Any symbol received other than /P/ following a /P/ symbol will lead to the state of BAD SSD
- □ Rewrite the transition condition between CARRIER DETECT and IDENTIFY JK
  - Change "rx\_bits[9:0] {equal to} 11111111000" back to "rx\_bits[9:0] {equal to} /I/J/"
- □ Enclose all branches and states which are only needed for EEE with dashed box and put a note saying Mandatory to LPI mode
- □ Correct the typo in the branch condition between RECEIVE and DATA
  - Change "rx\_bits[9:5] {not belongs to} DATA" to "rx\_bits[9:5] {belongs to} DATA"
