EEE Update for 1000BASE-T1

San Antonio, TX, USA

November 4, 2014

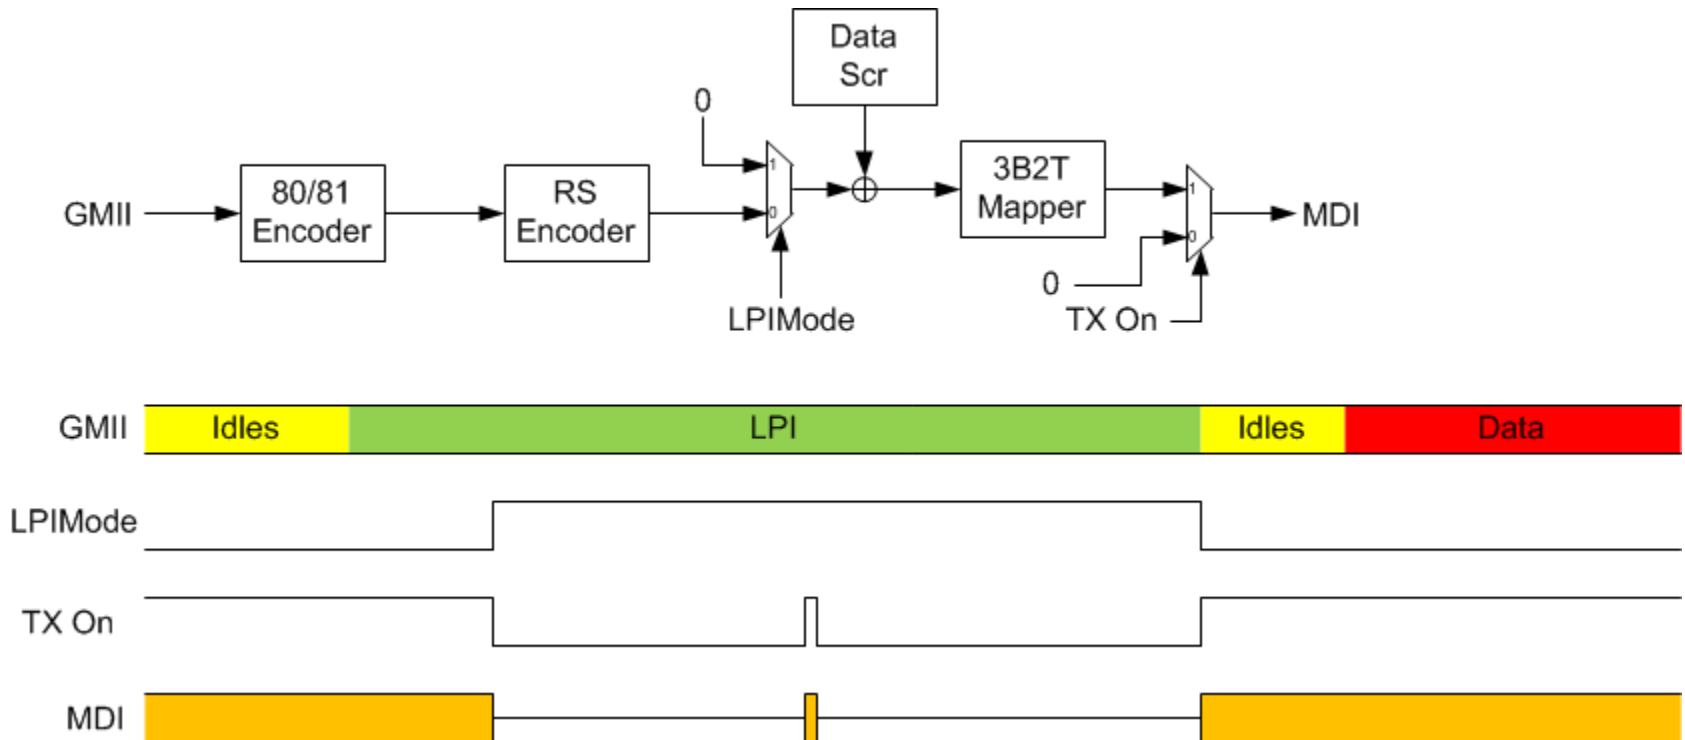
Refreshes (macro view)

- Scramble zeroes except OAM
- Scrambler after RS (tu_3bp_01_1114.pdf)
