TR-42 CORRESPONDENCE

RE: TR-42 Liaison to IEEE 802.3bt Task Force

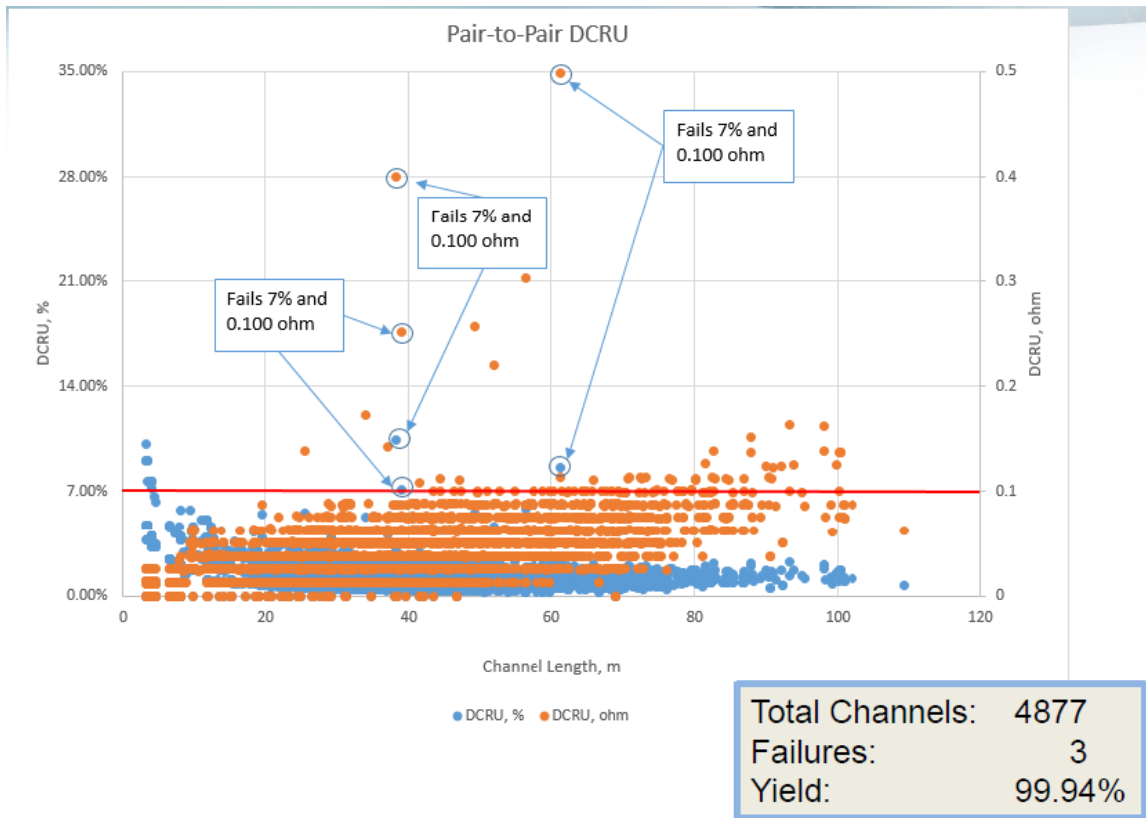
Figure 1 – DC Resistance Unbalance (pair to pair) for Channels

In figure 1, the DC resistance unbalance (pair to pair) when tested using the DC loop resistance method, expressed as a percentage is indicated as a blue dot and the same DC resistance unbalance value expressed in ohms, is indicated as an orange dot. A failure occurs when both the DC resistance unbalance is greater than 7% and the DC resistance unbalance value is greater than 0.1 ohms. For the results shown in Figure 1, there were only 3 failures in 4877 channels tested. These failures were examined and were determined to be installation specific, and are not due to cable or component deficiency.

In your communication of March 12, 2015 to TIA TR 42, a histogram of the DC resistance unbalance (pair to pair) data was requested. There were a number of contributions that were used to validate the DC resistance unbalance data shown in table 3. A representative sampling of this data is provided in figure 1 below:
