Component Issues for 100Base-LX10

Jerry Radcliffe
Hatteras Networks

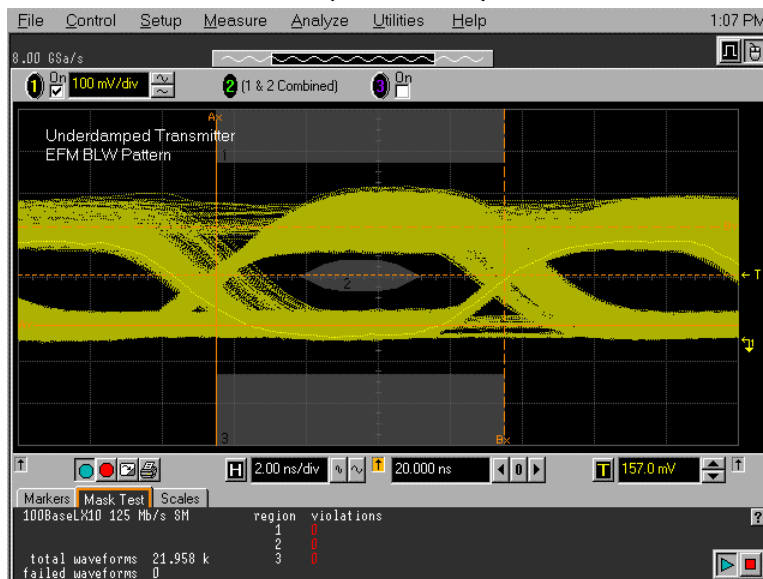
Eye Pattern using EFM BLW Test Pattern

- Both units pass the mask
- Triggering from the rising waveform edge
- Examined through a 4th order B-T filter w/ 3dB at 177MHz (OC-3)

Under-damped transmitter

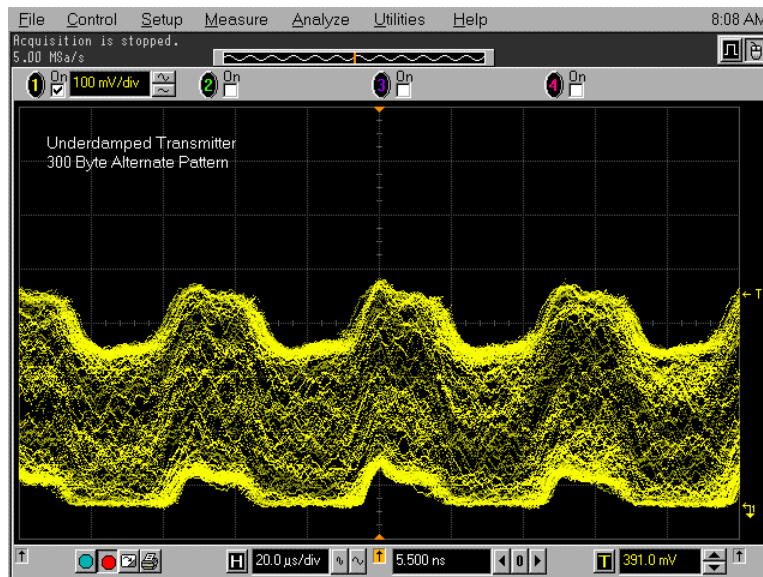
Optical Envelope with 300 Byte Alternate Pattern

- The under-damped unit has a large envelope perturbation
- The over-damped unit is very little amplitude change with this high frequency pattern

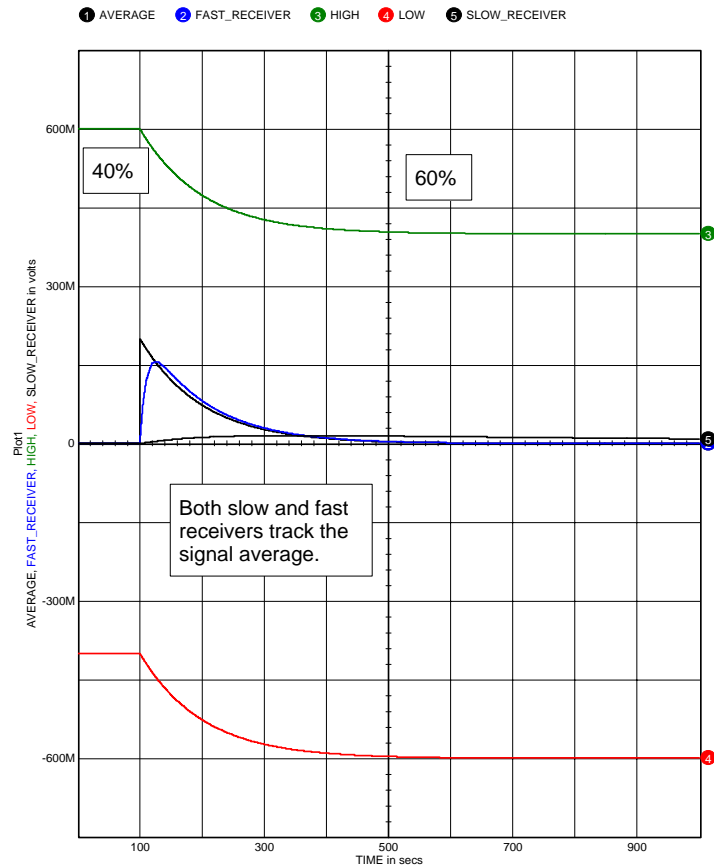
Simulation of Over and Under-damped Transmitters with Slow and Fast Receivers

Over-damped Transmitter

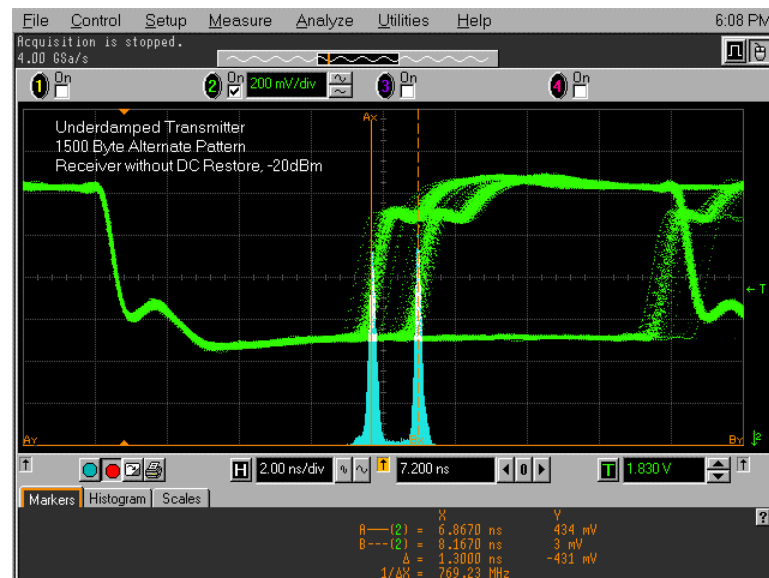
- The tests were run with 1500 Byte alternate pattern containing all zeros. The under-damped transmitter was used. Receive power level was -20dBm
- The receiver with DC restore has more jitter as a result of the feedback operation

Without DC Restore, 1.3ns jitter

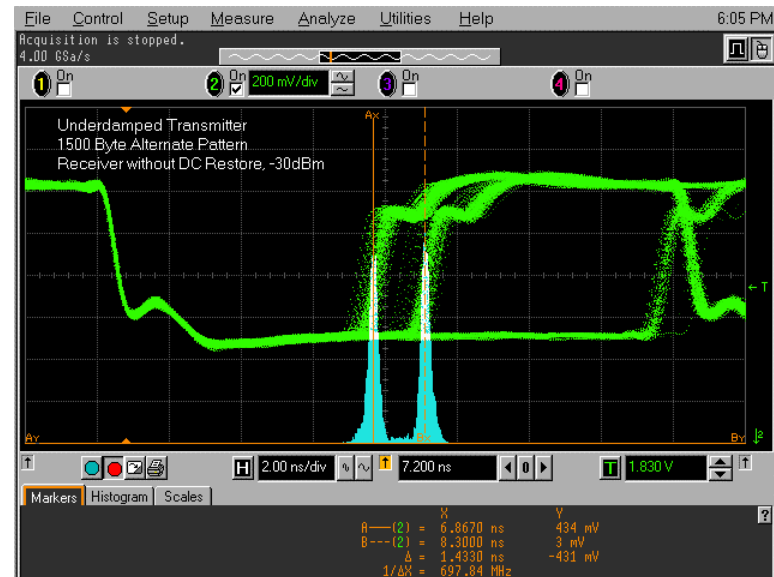
- Reducing the power to -30dBm increases the jitter in the DC restore case.
- In general, receivers with DC restore will have greater jitter than those without DC restore. These effects are power level and data dependent.

Without DC Restore, 1.4ns jitter
