# P802.1DD

## Comment 27 – Discussion

# Startup

# Comment 27

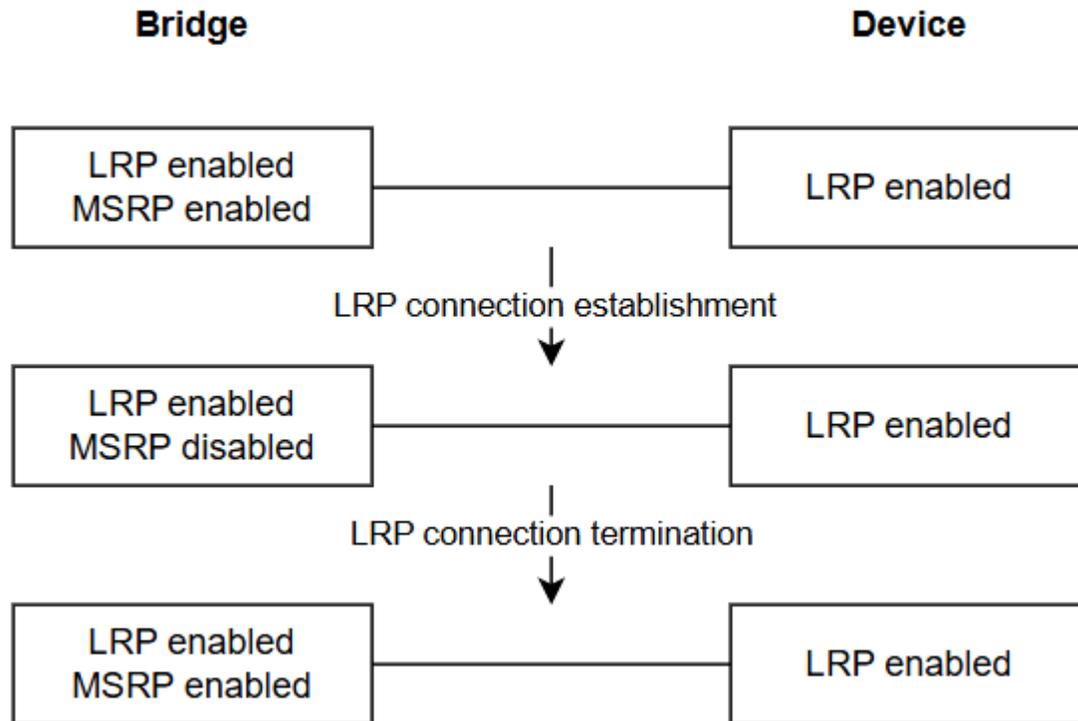
# Connection of LRP-only device

- After startup, both, LRP and MSRP are enabled in the bridge  
→ LRP or MSRP connection can be established

- After detection of LRP disconnection, MSRP is enabled in the bridge again

-> No problem

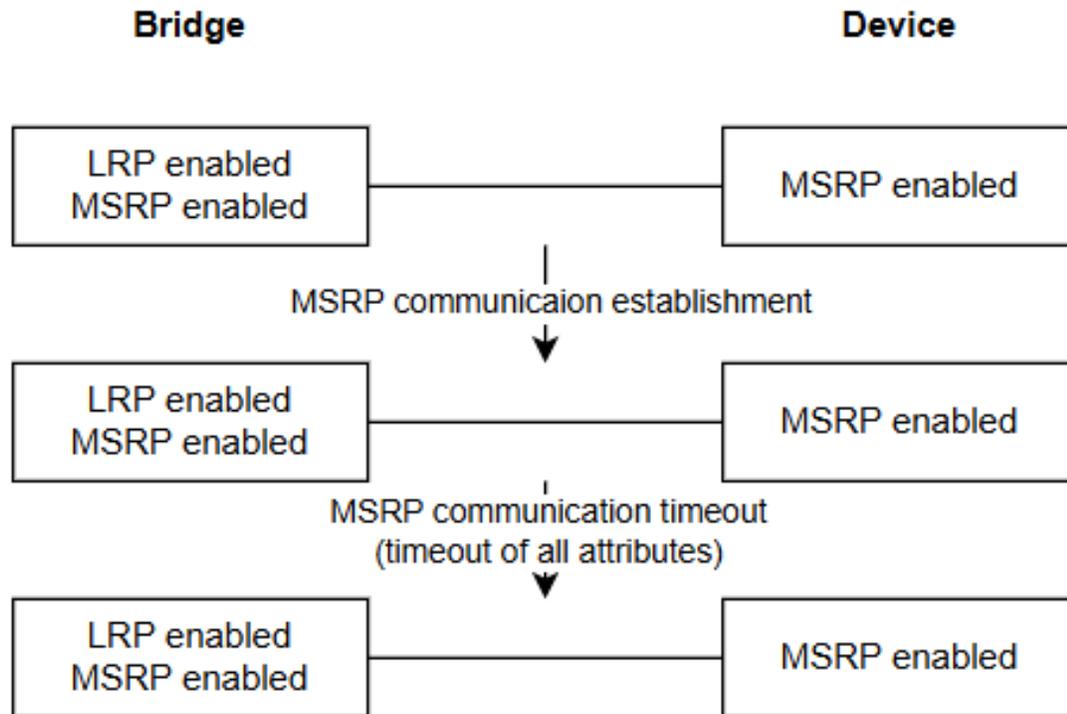
# Connection of MSRP-only device (as specified currently in 1DD d1.4)

- After startup, both, LRP and MSRP are enabled in the bridge  
→ LRP or MSRP connection can be established
- Both, LRP and MSRP is always enabled in the bridge

-> No problem

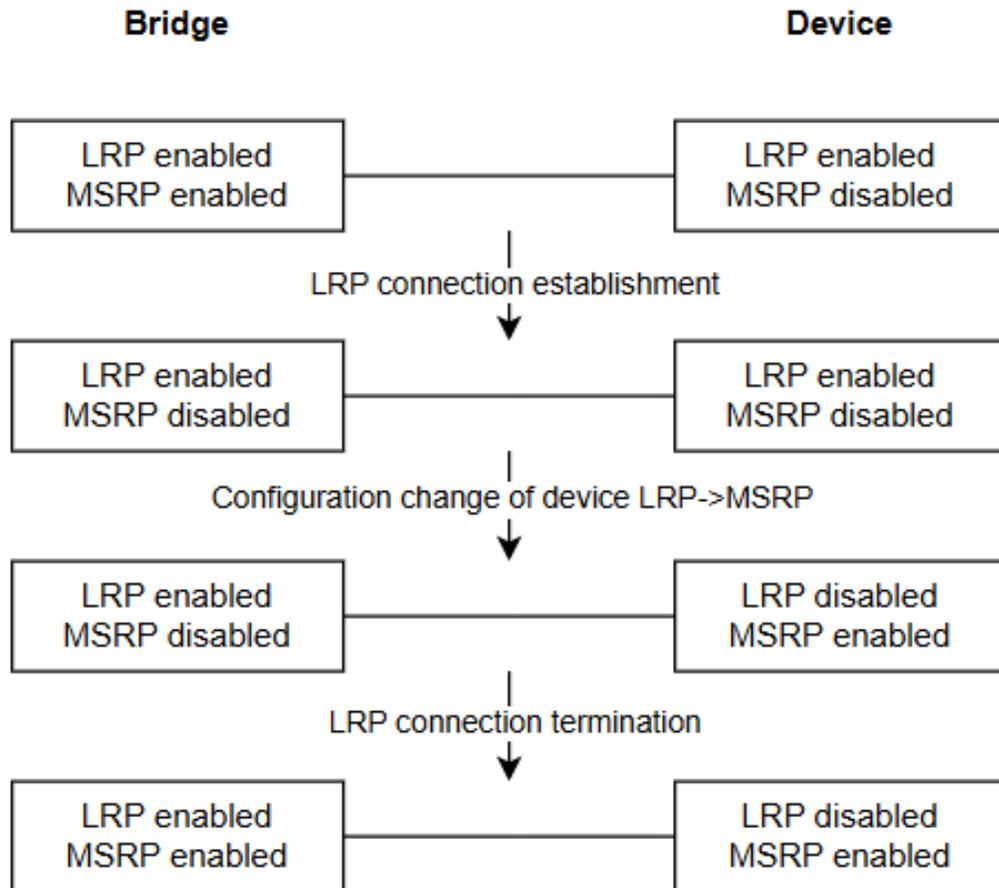
# Connection of mixed-mode device (configuration change LRP -> MSRP)

- After configuration change from LRP to MSRP, the LRP connection is terminated and thus MSRP reactivated in the bridge

-> No problem

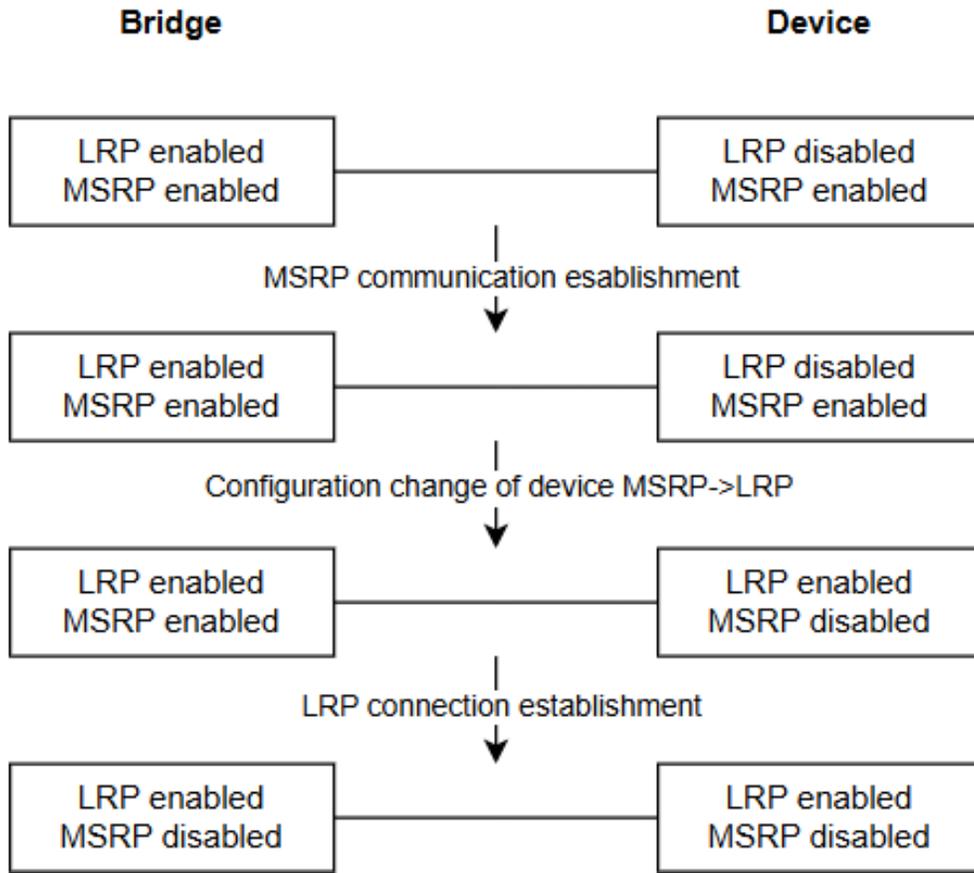
# Connection of mixed-mode device (configuration change MSRP -> LRP)

- After configuration change from MSRP to LRP, an LRP connection establishment is issued by the device
- This leads to termination of currently active MSRP communications by the bridge

-> No problem

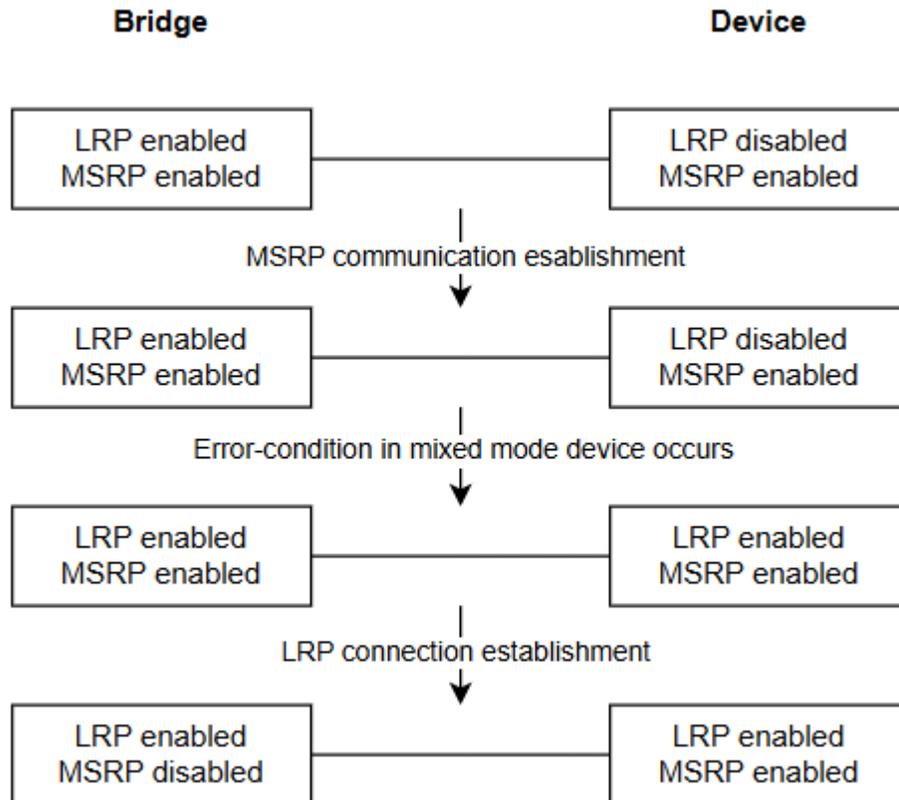
# Erroneous mixed-mode device (activating both, MSRP and LRP)

- A mixed-mode device starts MSRP communication
  - Additionally the devices tries to establish an LRP connection
- > This is not allowed and leads to termination of all active MSRP attributes

- Only erroneous mixed mode devices that start LRP communication while already doing MSRP communication can cause issues

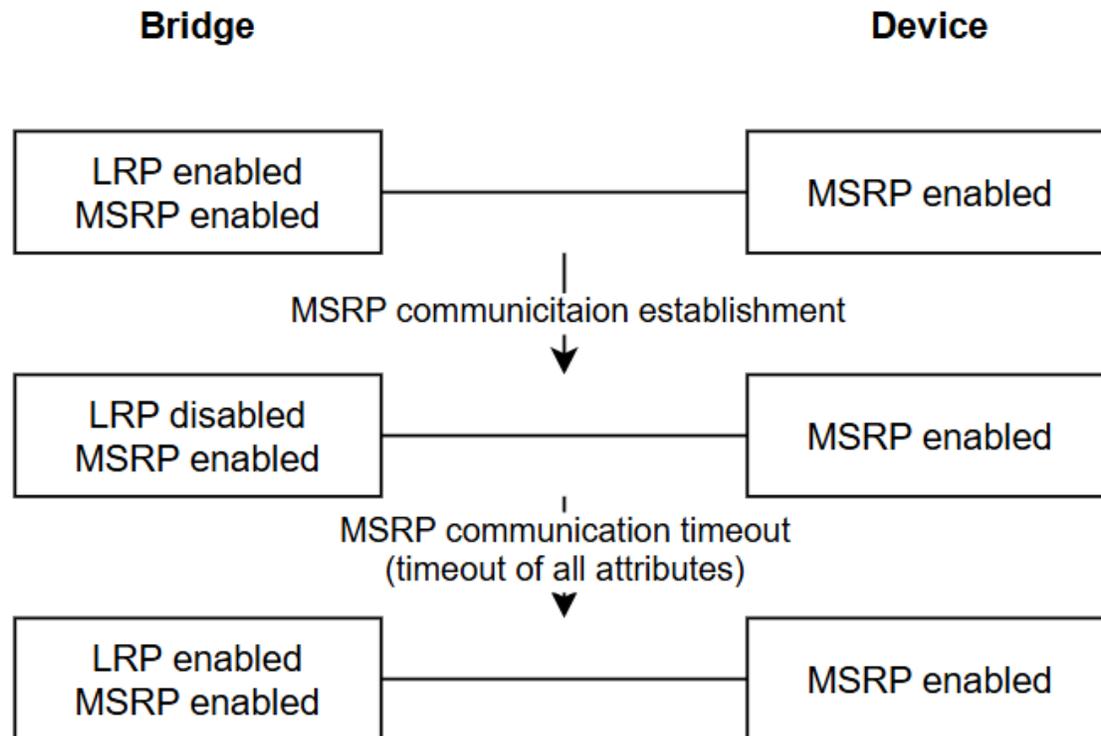
# Disabled LRP in the bridge in case of MSRP communication

- Disabling of LRP in case of MSRP communication establishment would solve the problem
- But there is additional complexity in the bridge to detect timeouts of MSRP attributes

- Disabling LRP for this port in the bridge in case that MSRP communication is started could prevent this issue
- But there is no easy possibility to detect if the MSRP communication is no longer needed
  - -> timeout of all MSRP attributes could be one solution
