Addressing PTP timestamp accuracy for 800GBASE-ER1 with an 800GMII Extender

800GBASE-ER1 Architecture with 800GMII Extender

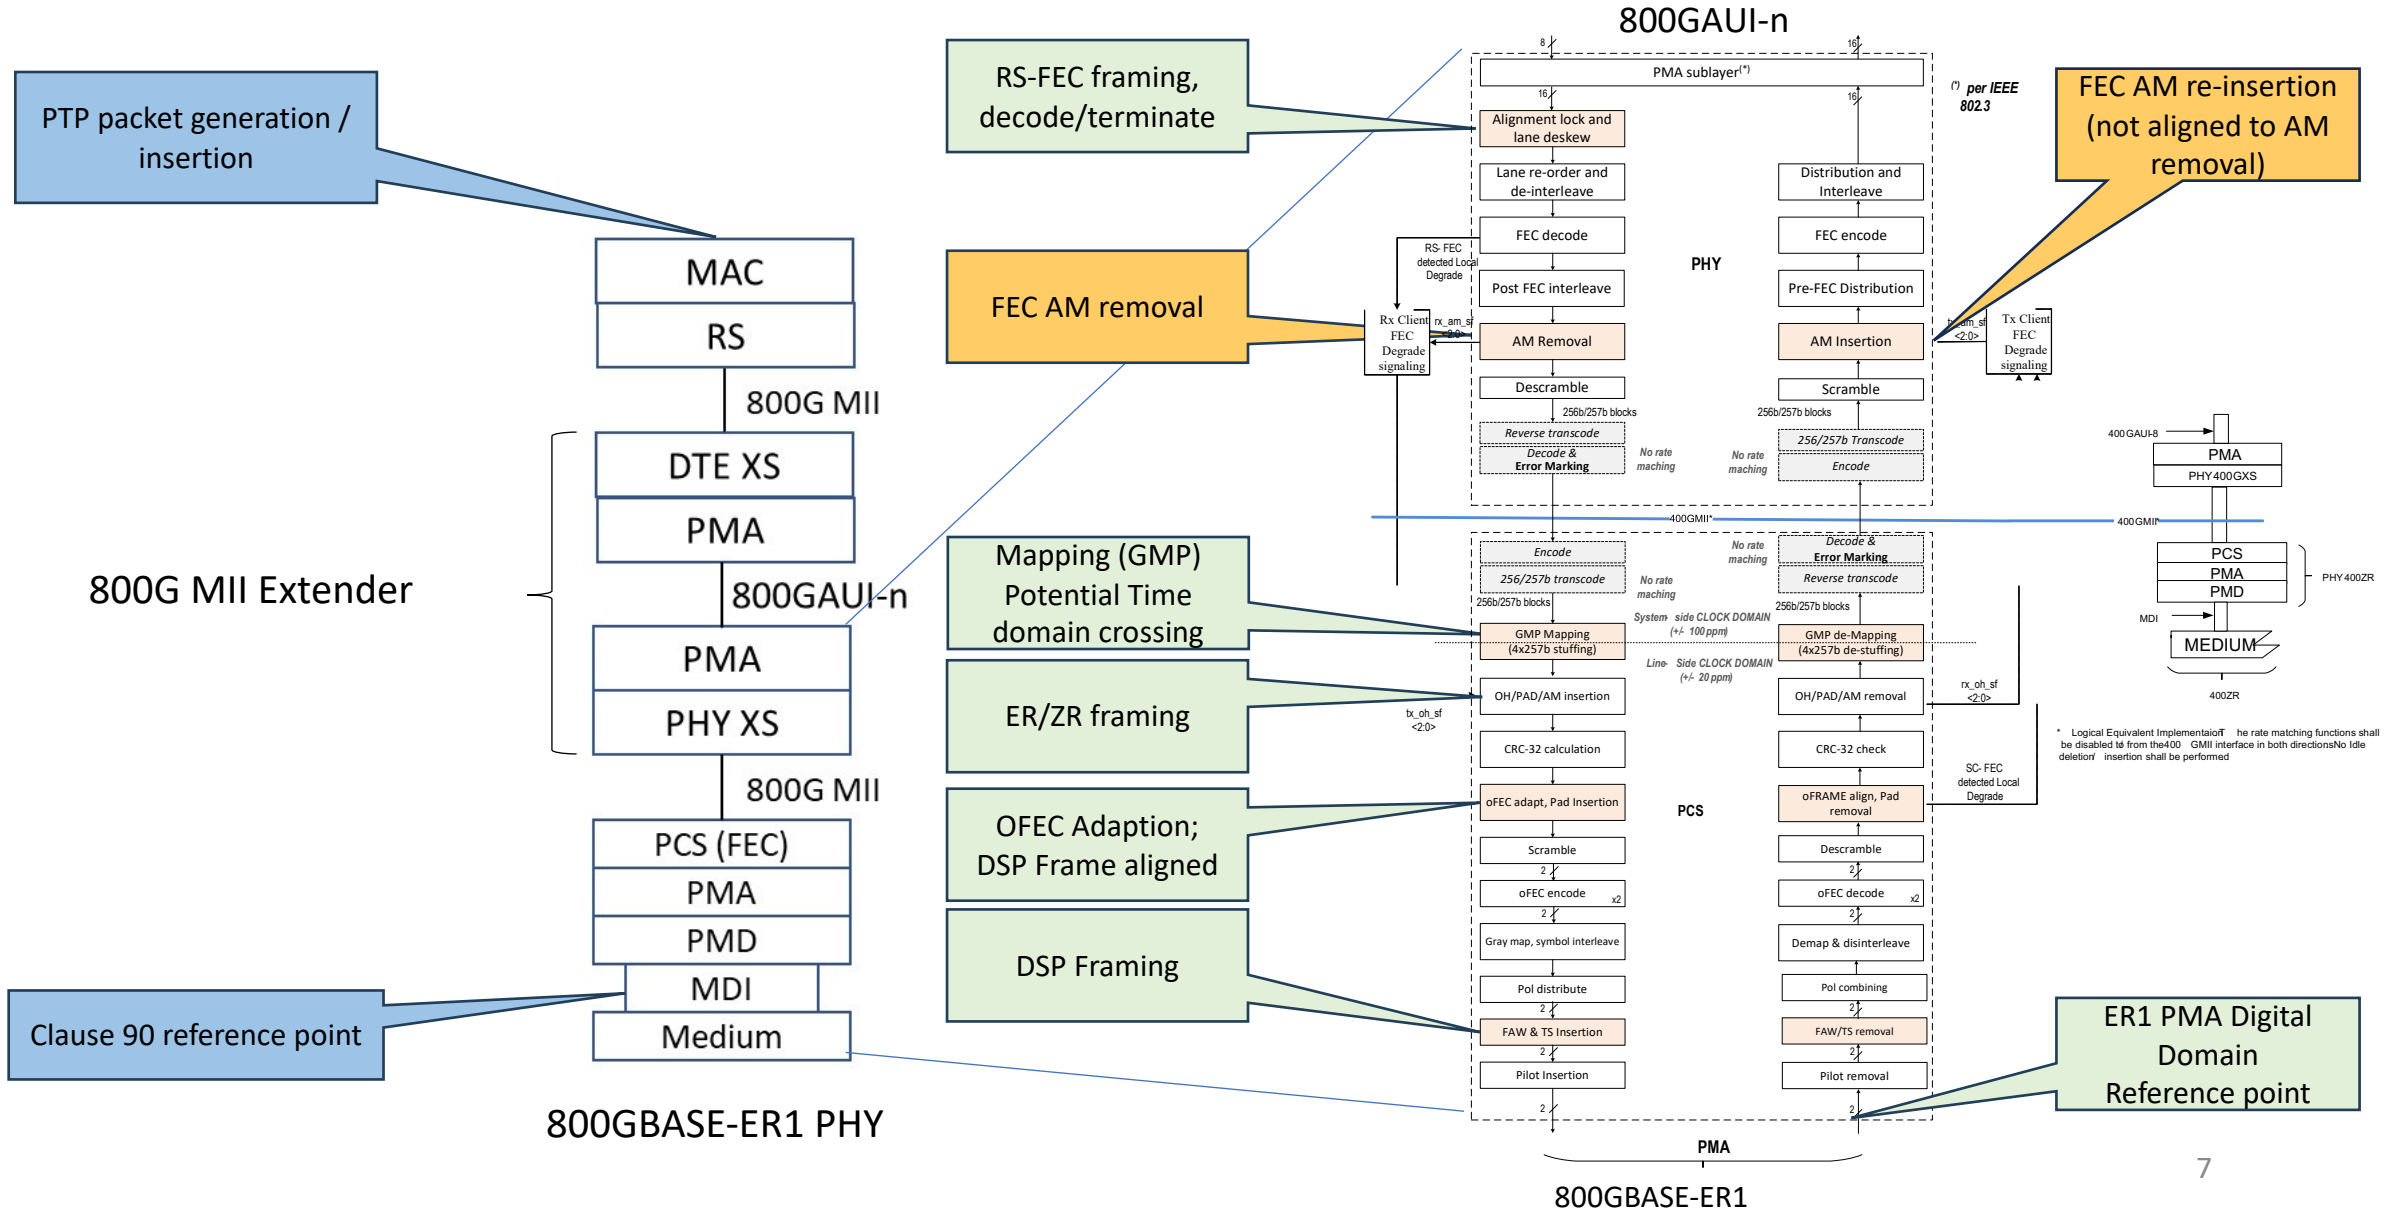
- A solution is proposed that ensures AMs are re-inserted in the same positions by the receive 800GMII Extender, relative to whether they were removed by the transmit 800GMII Extender.
- This preserves the Host-to-Host timing relationship of the underlying PTP packet across the 800GBASE-ER1 link.

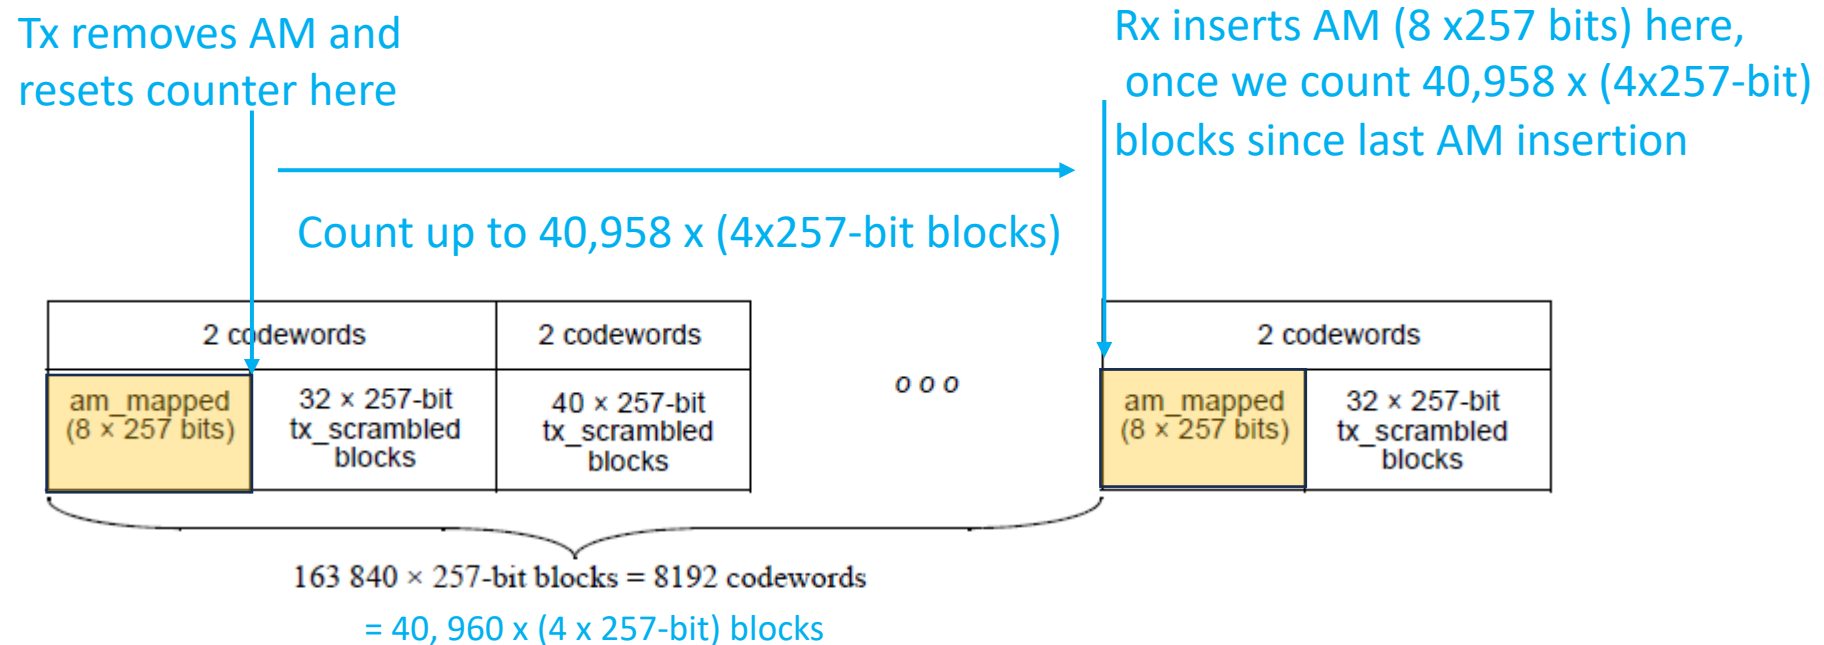
Figure 119-8—400GBASE-R alignment marker insertion period

- AM are inserted between the payload block where the counter equals 40957 and the payload block where the counter equals 0.

- The purpose of the Counter is to convey the TX_START/END (Point when AM removed at TX mapper) to RX_START/END (Point where AM insertion is required in RX de-mapper)

- Count value is initialized to zero by the TX GMP mapper, aligned to the removed AM fields. It increments every 4 x 257b valid data block. The Max Modulo is the expected end of the 4 x 257b valid data for the RS AM marked interface. RX de-mapper keeps equivalent RX counter and synchronizes to JC9-JC7 signals.
